# **Appendix B. Section 106 Consultation**

# Historic Property Report

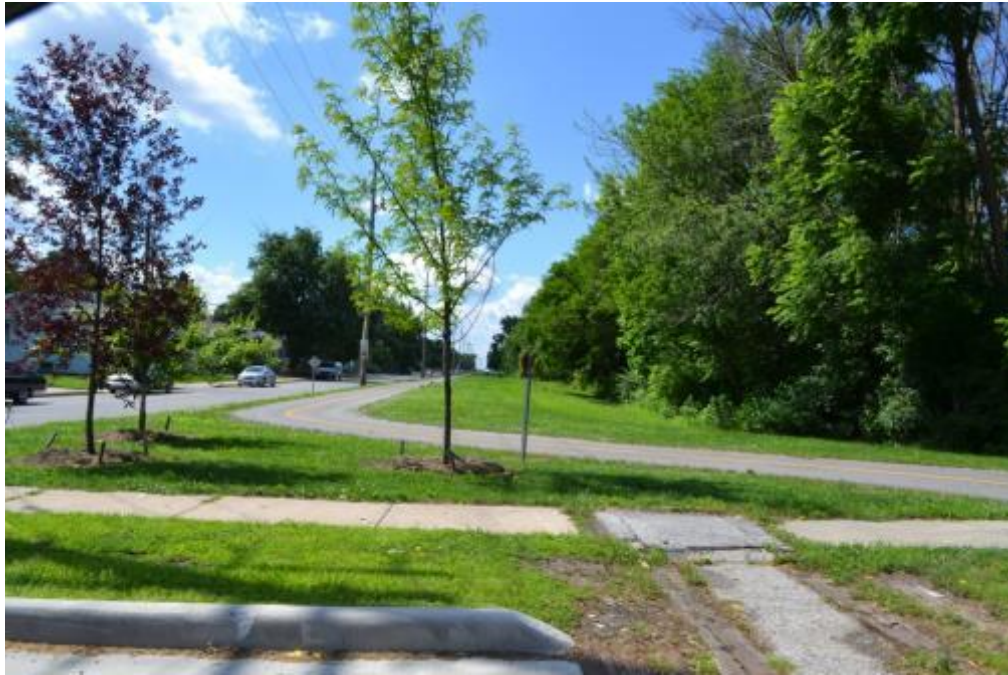
**Figure 5-1: Former Monon Railroad Alignment in Hammond  
(view south from Conkey Street)**

Several segments of the railroad tracks have been removed, particularly in Hammond where a bicycle/pedestrian trail is installed along the alignment and at the former location of the Chicago & Erie and Monon rail yards (**Figure 5-1**). In Hammond, short segments remain at street intersections. In Munster, although defunct, long segments of the railroad tracks remain in situ (**Figure 5-2**). These show some signs of deterioration at the ties and, in some places, misaligned tracks. This disused segment extends south from the Little Calumet River crossing to just north of 45th Street in Munster. Along this segment, an overhead crossing is located at the intersection of Broadmoor Avenue (**Figure 5-3**), and an underpass is located at Belden Avenue in Munster. The overhead crossing consists of concrete abutments with a short span of steel I-beam girders supporting wood rail ties and rails above with no guardrails. The underpass is an arched concrete tunnel with concrete abutments. Two other segments of the former Monon Railroad line in the APE, including a segment to the north at the state line, extending from Hammond to Burnham, and a segment to the south, extending from St. John to Munster, are in active use by CSX.

compromised due to the deterioration and disuse of the line, as well as modern infill surrounding it. Therefore, the Monon Railroad segment in the APE is not eligible for the NRHP.

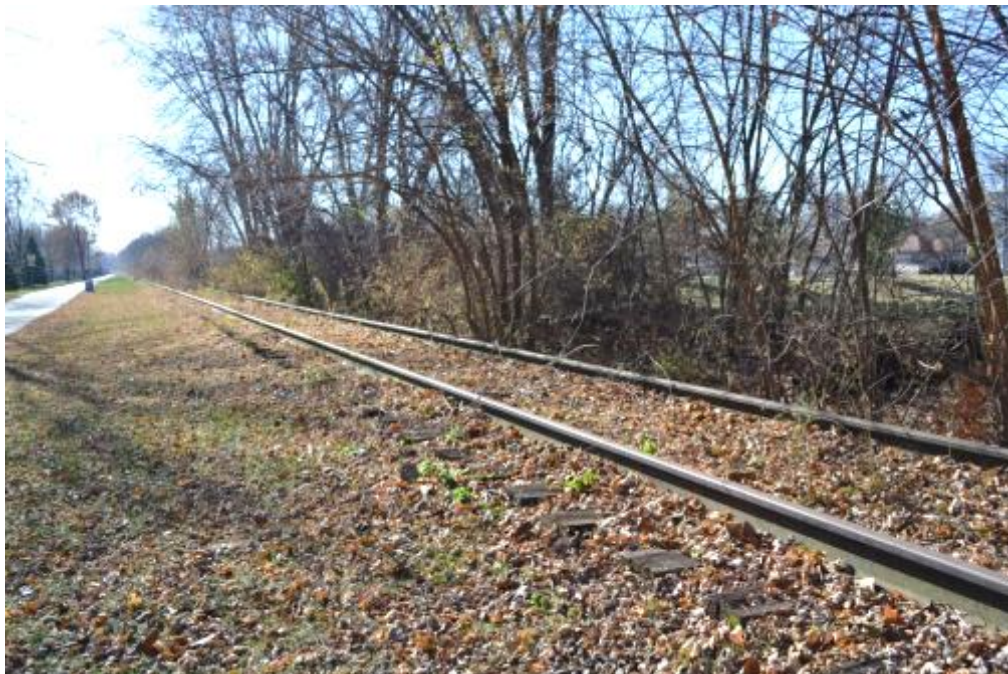
**Figure 5-2: Monon Railroad Segment in Munster (view south)**

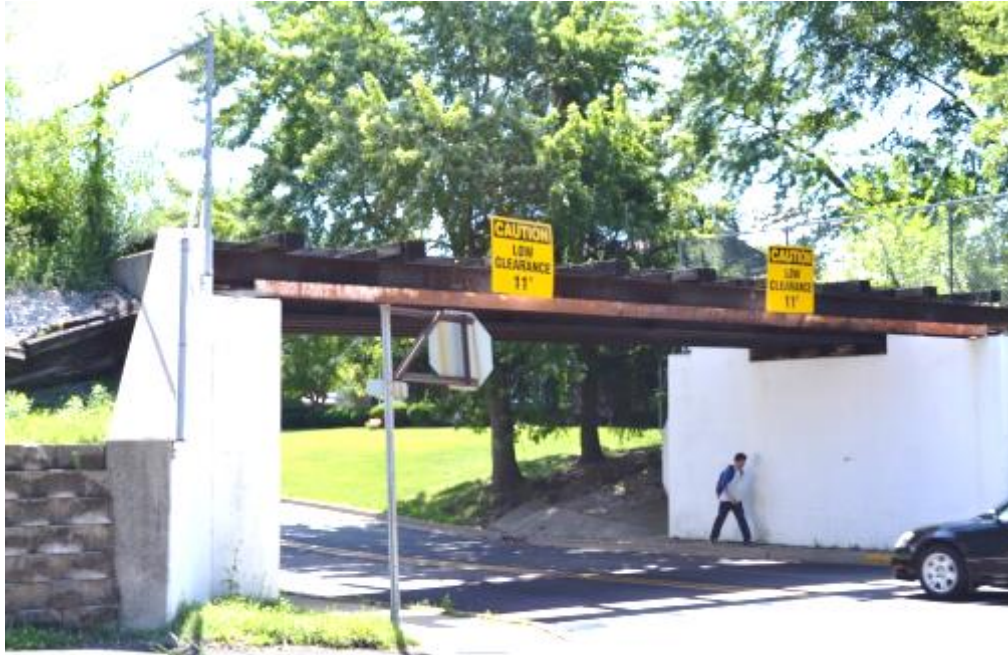
**Figure 5-3: Monon Railroad Overhead Crossing at Broadmoor Avenue in Munster (view southeast)**

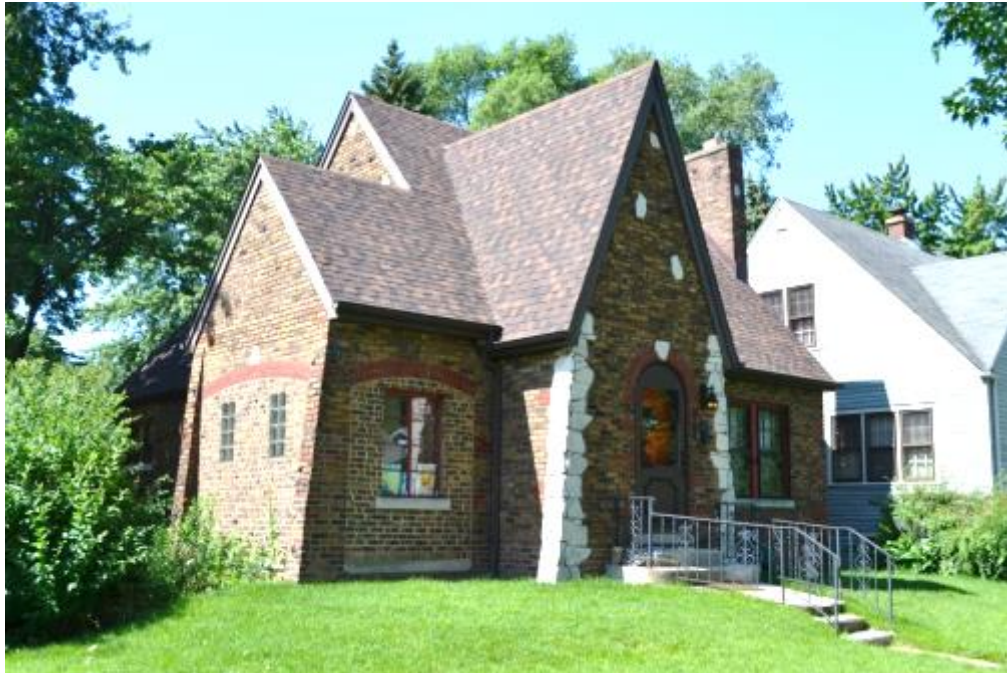
The property located at 266-268 Oakwood Street in Hammond is a house with an irregular plan with a high-pitched, multi-gabled roof, and is set back from the corner of Oakwood Street and Lyman Avenue (**Figure 5-4**). The main building has a cross-gable plan, with a projecting gabled entrance on the north (front) side, a projecting gabled porch on the east side, and an attached one-story garage on the south side. According to the 1951 Sanborn Fire Insurance Map of the property, the house is brick-faced tile construction. The brick is interspersed with decorative stone quoining at the entrance and stone, brick, or tile accents. The north façade contains the dominant front gable with the entrance, which is a stylized, wood, round-arched door with a metal grill and knocker with a brick and stone arch above (**Figure 5-5**). The elevated entrance has concrete steps at its threshold that lead to a curved walkway in the front lawn that meets the sidewalk on Oakwood Street. West of the entrance, the façade contains three ribboned sash windows, with a continuous concrete or stone sill. A brick chimney rises from the front of the side gable at the eastern wall. East of the entrance, a side-gabled porch with buttressed corners projects from the main building. The three exterior sides of the porch contain segmental-arched openings with brick or tile accents. The concrete base or sill of the porch is visible, but the porch arches have been enclosed with infill brick walls. The house has varying, but consistent, fenestration with continuous concrete or stone sills and plain brick surrounds. The windows appear to be replacement steel sash, metal casement, and glass block. The steep roof is covered with asphalt shingle roofing.

**Figure 5-4: 266-268 Oakwood Street (view southeast)**

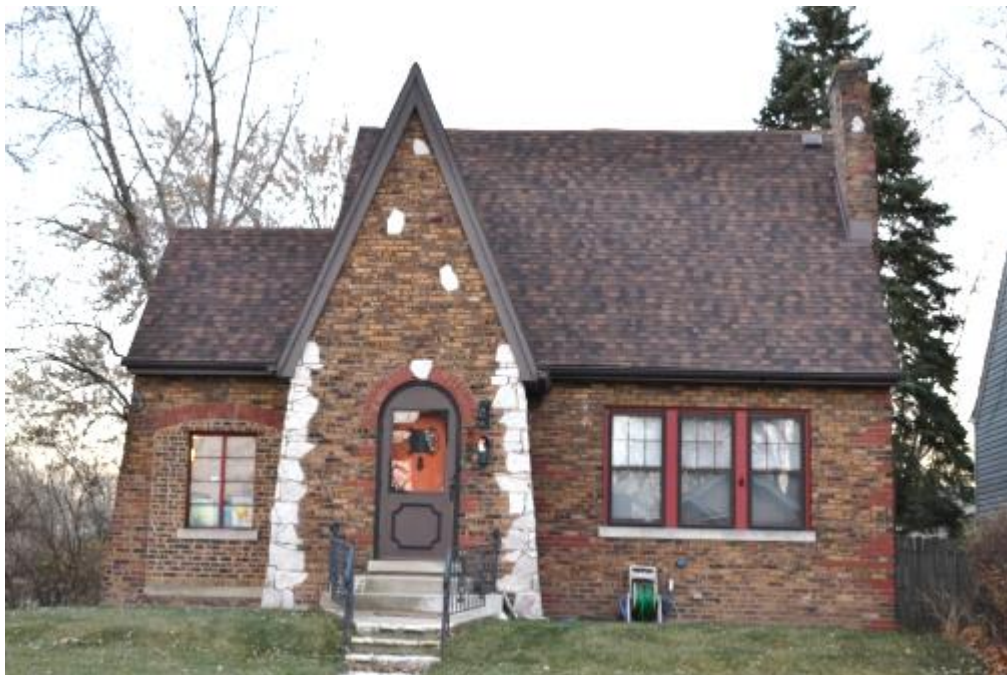
**Figure 5-5: 266-268 Oakwood Street (view south)**

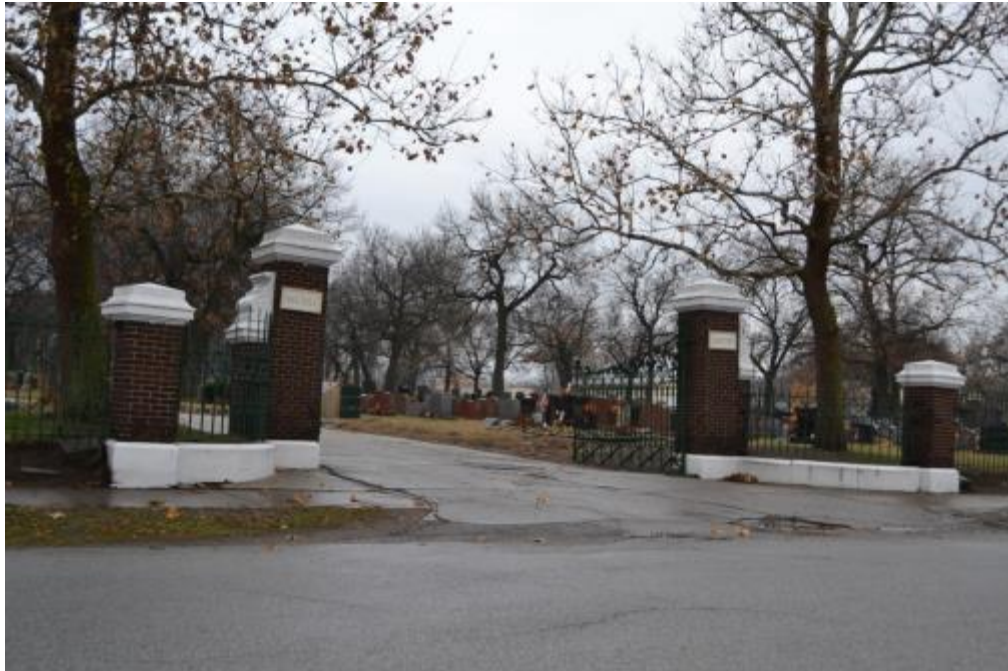
The Oak Hill Cemetery is an approximately 22-acre cemetery that was founded in Hammond in 1885. The cemetery has more than 10,000 interments, including early settlers and founding members of the community, Civil War veterans, and other historical graves (Chase 2013; Graper 2012). The cemetery is bounded by Kenwood and 165th Streets on the north and south and Hohman and Blaine Avenues to the west and east, respectively. The main entrance to the cemetery is on Kenwood Street. The ornamental metal front swing gate has brick end piers with decorative capitals and corbels and concrete bases (**Figure 5-6**). The entire cemetery is enclosed by fencing. The fencing adjacent to the entrance gate is decorative metal and the rest of the cemetery is enclosed by chain-link fencing. Asphalt-paved roadways provide vehicle and pedestrian access to the interior of the cemetery (**Figure 5-7**). There is a modular building and a prefabricated steel building at the western border of the property that serve as the cemetery office and maintenance shed.

**Figure 5-6: Oak Hill Cemetery, Front Gate (view southwest)**

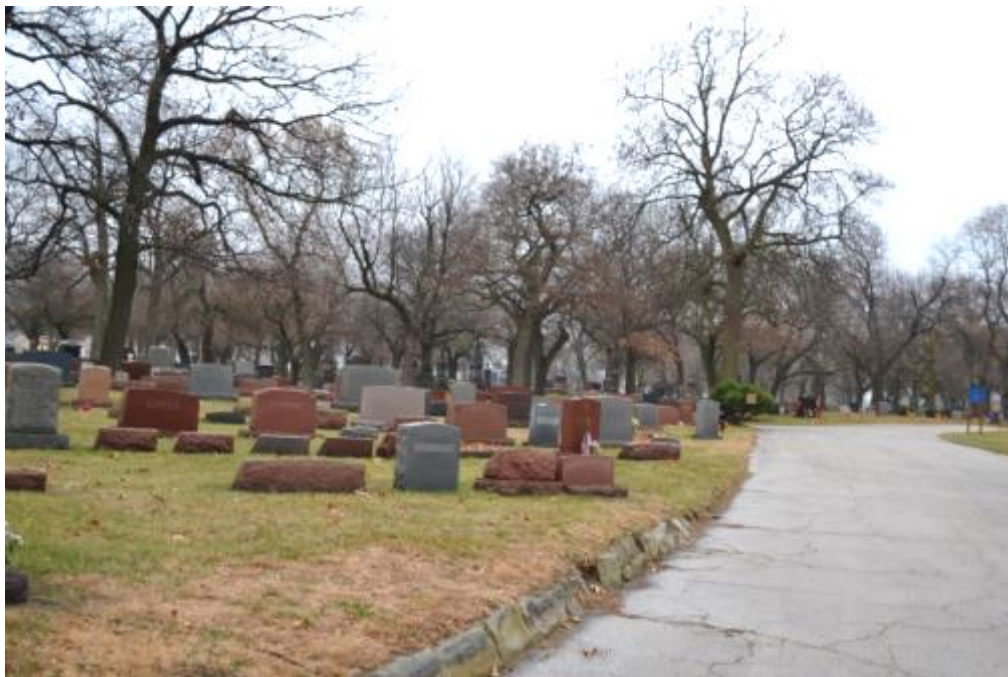
**Figure 5-7: Oak Hill Cemetery (view south)**

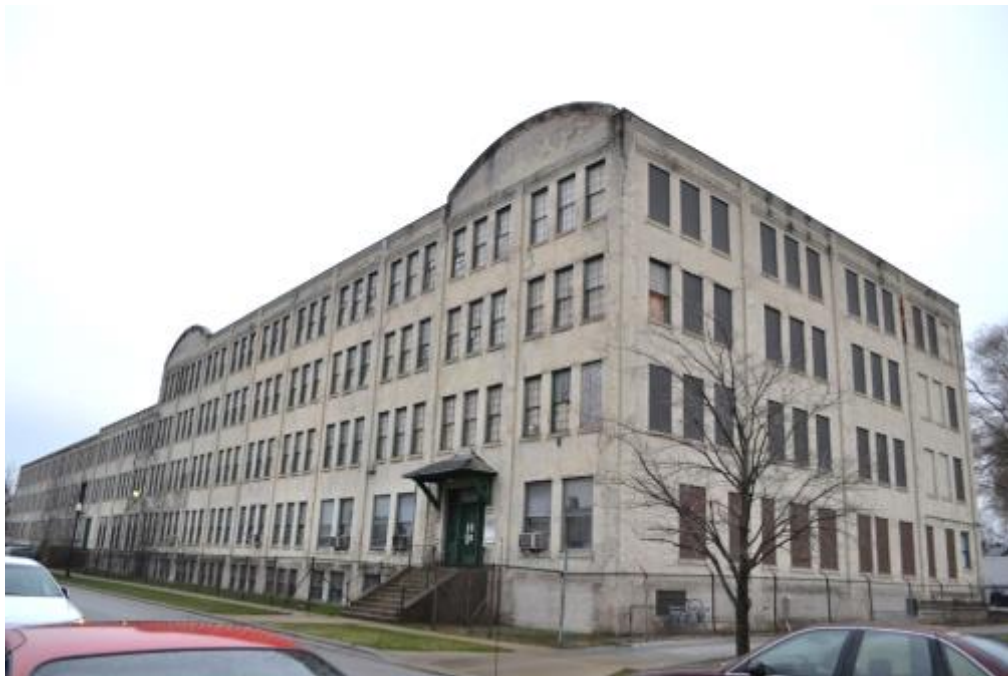
The Straube Piano Company is a large industrial complex. The main factory building has a T-shaped plan consisting of two major sections – the original 1904 three-story, an L-plan building to the east, and the 1924 four-story addition to the west, with an additional section at the center (**Figure 5-8**). The original building is 10 bays long by two bays wide with a perpendicular wing that extends an additional six bays to the south. Each bay contains three nine-over-nine sash windows in each story. The first-story bays contain doors or windows with square or segmental arched headers, and the upper stories contain windows with segmental arched headers and stone sills. The cornice of this section consists of simple bands of stepped brick. The center addition is four bays wide, and repeats the pattern of the original section with a minor difference at the cornice and building height. The four-story addition to the west is 10 bays long and four bays wide. The addition contains the same fenestration pattern of three windows in each bay. The windows are nine-over-nine sash with square headers. The cornice has arched parapets at each end of the addition.

**Figure 5-8: Straube Piano Company (view southeast)**

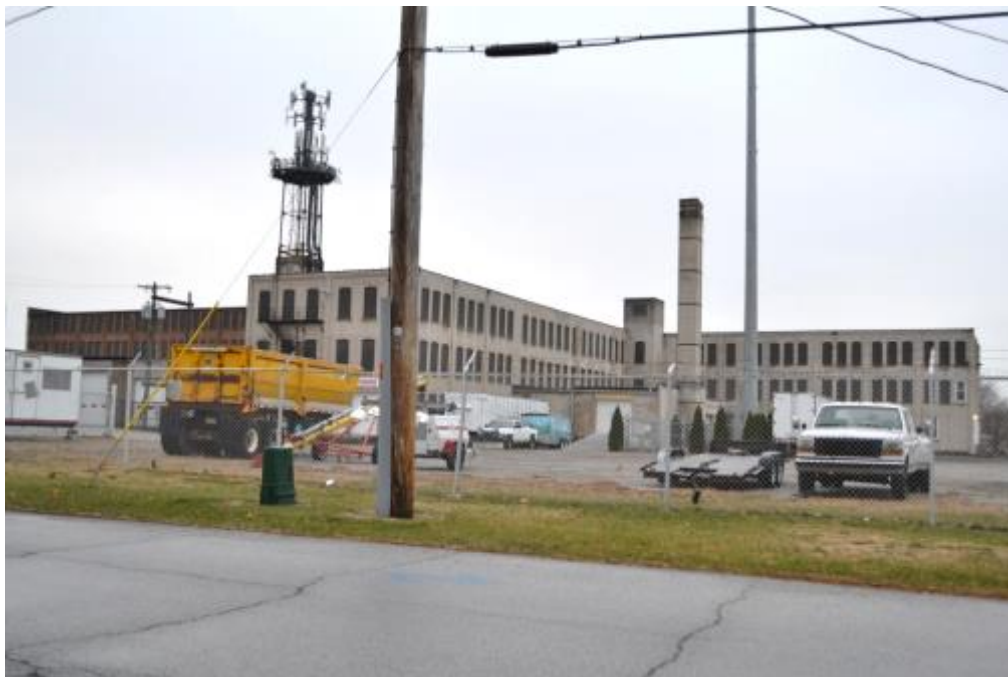
The rear of the factory consists of the original section of the factory to the east and the 1924 addition to the west (**Figure 5-9**). The east side repeats the fenestration pattern of the façade, with three windows in each bay. Also on the east side, a one-story boiler room and stack are attached to the rear wing. The rear of the western section has red brick exterior walls, and also repeats the regular fenestration pattern of the façade. The perpendicular rear wing addition is one story. At the intersection of the rear wing addition, a cellular phone tower has been installed above a five-story tower that once held a water tank for its automatic fire sprinkler system.

**Figure 5-9: Rear of Straube Piano Company (view northwest)**

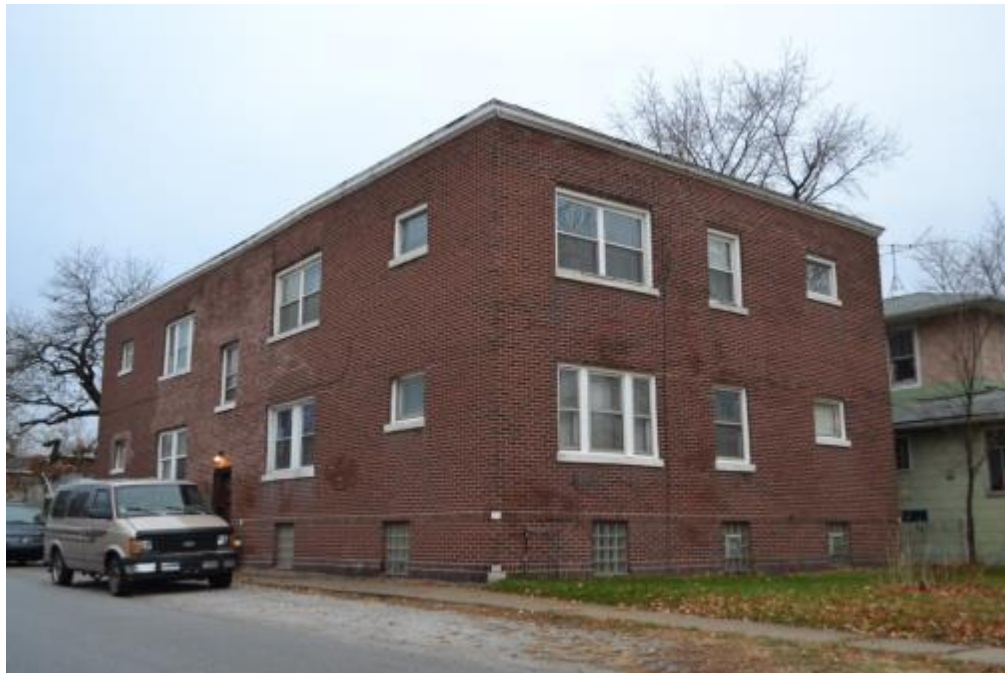
The apartment building at 6136 Lyman Avenue is a two-story, four-flat, five-bay multi-family residence with a rectangular plan, brick exterior walls, and a flat roof (**Figure 5-10**). The building is located at the southwest corner of the intersection of Dyer Boulevard and Lyman Avenue and is on the edge of the Dyer Boulevard Historic District. It faces east on Lyman Avenue with a symmetrical façade that has a central entrance in the first story with a modern metal panel door, a central interior stairwell, and mirrored fenestration on each side. The building contains four apartments, two in each story on either side of the central access. The exterior walls have few decorative elements, with a water table band of rowlock bricks above the basement and a simple molded cornice. Fenestration includes wood framed, single, paired, and triple 1/1 double-hung sash and single pane fixed windows with limestone sills, and glass block windows at the basement level. Some windows have been replaced with modern materials, with changes from triple to paired sash configurations using modern materials.

**Figure 5-10: 6136 Lyman Avenue (view southwest)**

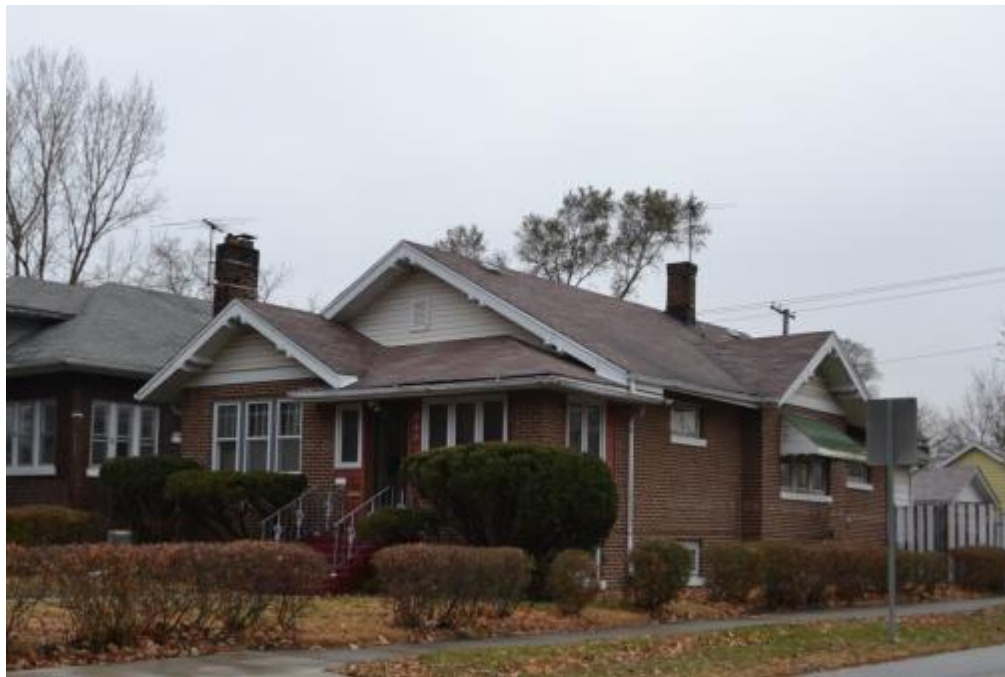
The house located at 267 Dyer Boulevard was constructed in the Bungalow style in 1923 (**Figure 5-11**). The one-story wood-framed residence has an asymmetrical plan with a front gabled main roof with an inset front gable at the façade, a cross gable on the east side, and a rear gabled back porch entry. The roof is sheathed with asphalt shingles, and has overhanging eaves with decorative wood rafter tails. The exterior walls are brick with clapboard in the gable ends. The asymmetrical façade includes a porch on the east side with a hipped roof and brick rails with limestone coping and a brick pier porch support; the porch has been enclosed with modern windows and siding. On the west side, the exterior wall contains three modern sash windows with decorative mullions in the top sash with a stone sill. Other windows appear to be wood single pane fixed or casement windows, and aluminum and vinyl replacement sash windows.

**Figure 5-11: 267 Dyer Boulevard (view northwest)**

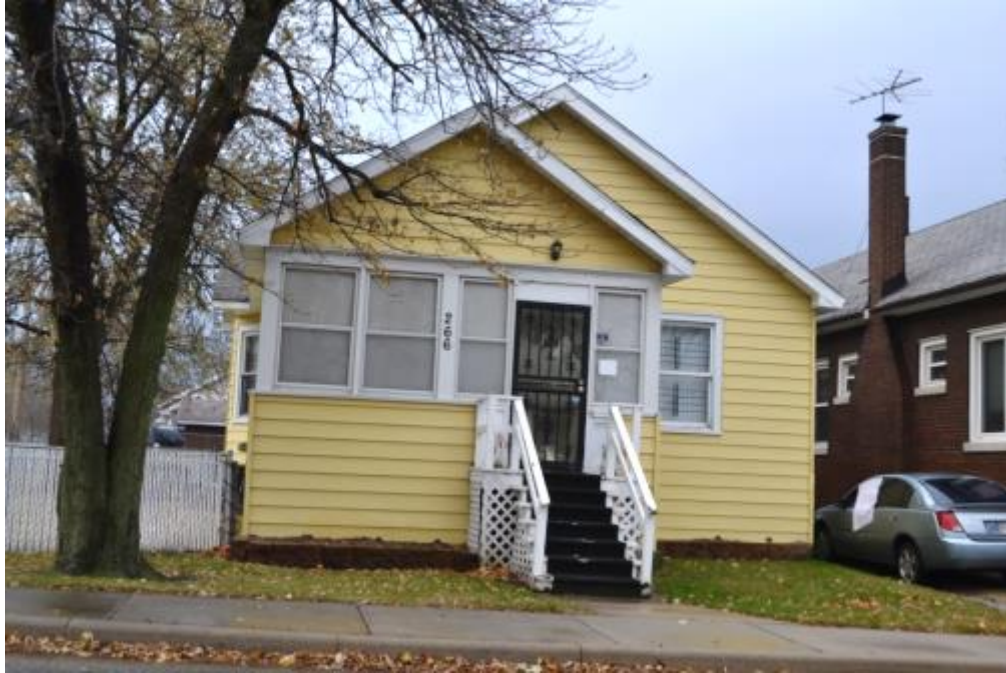
**Figure 5-12: 266 Detroit Street (view south)**

The house at 266 Detroit Street is a Bungalow-style residence constructed in 1912. (Figure 5-12). The one-story wood-frame structure has a basement and the foundation is concrete. The front gable roof is sheathed with asphalt shingles and has boxed eaves.

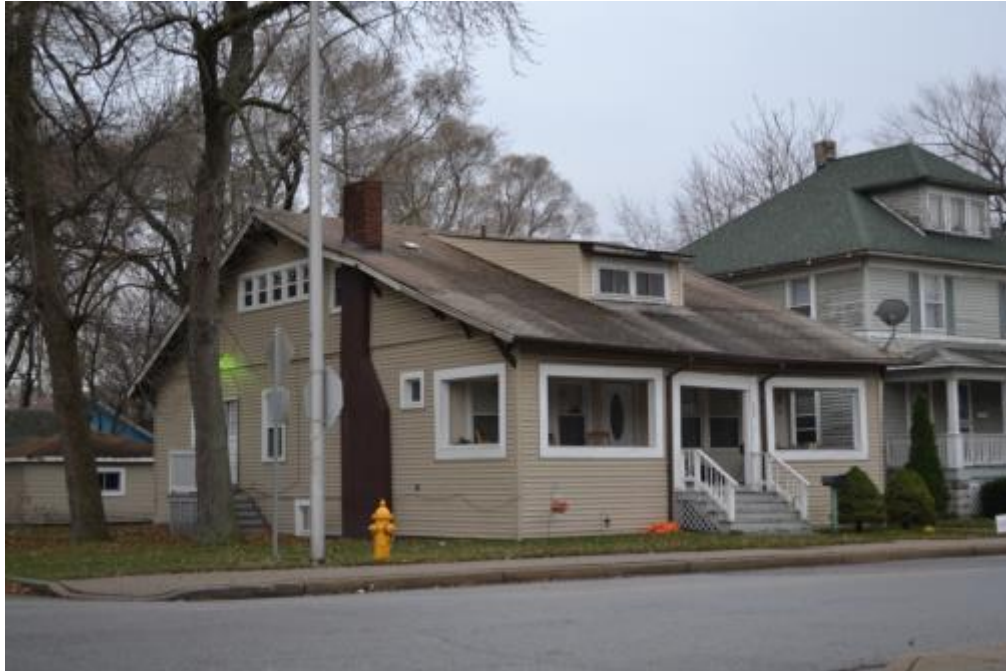
**Figure 5-13: 266 Highland Street (view southwest)**

The house at 266 Highland Street was constructed in the “Broadside” Bungalow style in 1917 (**Figure 5-13**). It is a one-and-one-half story wood frame structure with a concrete foundation. The side gable roof is sheathed with asphalt shingles and has wood brackets. There is a shed-roofed dormer with two adjacent aluminum-framed sliding windows with the original wood-framed screens and wood surrounds.

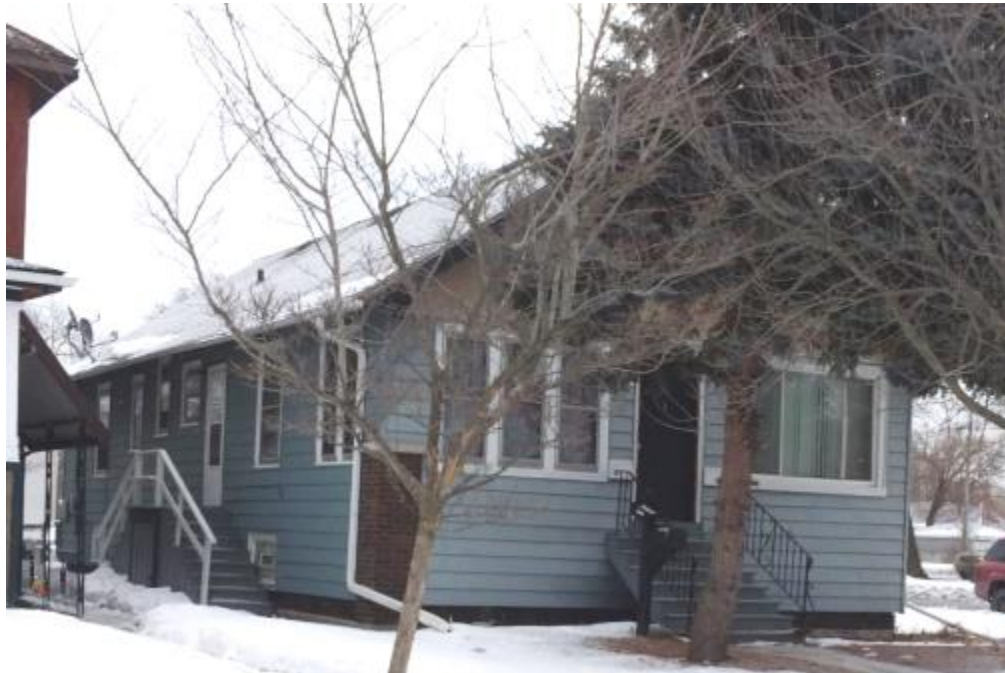
The house at 5973 Park Place was constructed in the Bungalow style in 1915 (**Figure 5-14**). The residence is a one-story wood frame structure with a simple, box-like shape and a front gable roof.

**Figure 5-14: 5973 Park Place (view southeast)**

The original front porch has been infilled. One original brick support pier remains extant on the northwest corner of the porch. The roof is clad with asphalt shingles and has wood brackets on the gable ends. The south side of the building features an exterior brick chimney framed by two small wood frame multi-light awning windows and a cross gable with a bump out window. Other windows are a mixture of original 1/1 wood frame double-hung windows, and modern vinyl 1/1 double-hung windows and three-light picture windows with side casements. All windows have wood surrounds. Basement windows are fixed glass block windows. Wood stairs with metal railings provide access to the single entry front door.

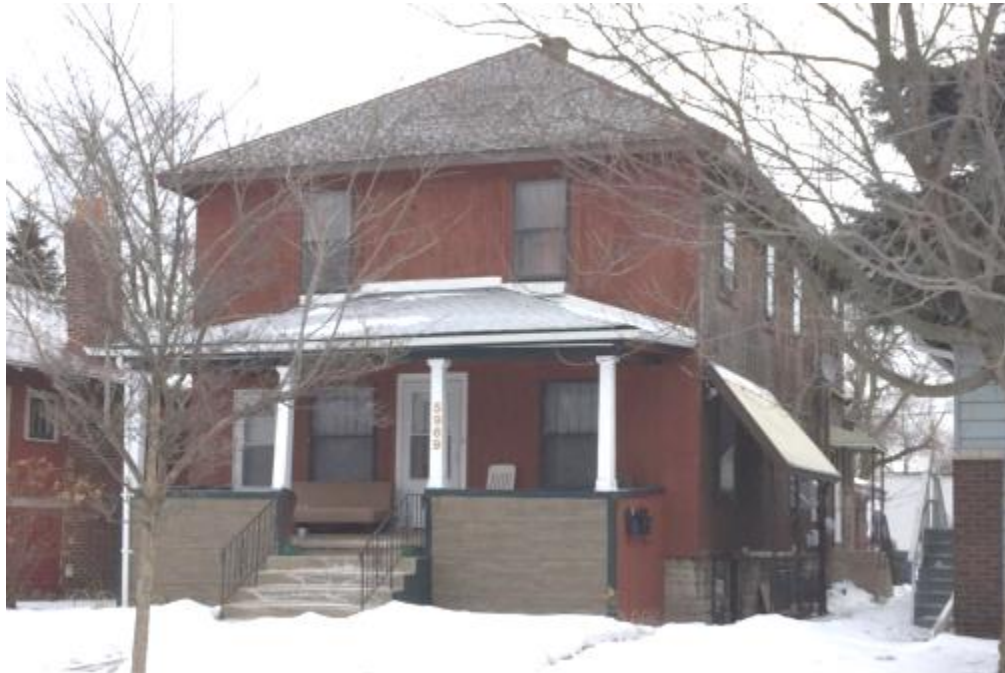
**Figure 5-15: 5969 Park Place (view northeast)**

The house at 5969 Park Place was constructed in the American Foursquare style in 1915 (Figure 5-15). The residence is a two-story, wood frame structure with a hipped roof clad with asphalt shingles.

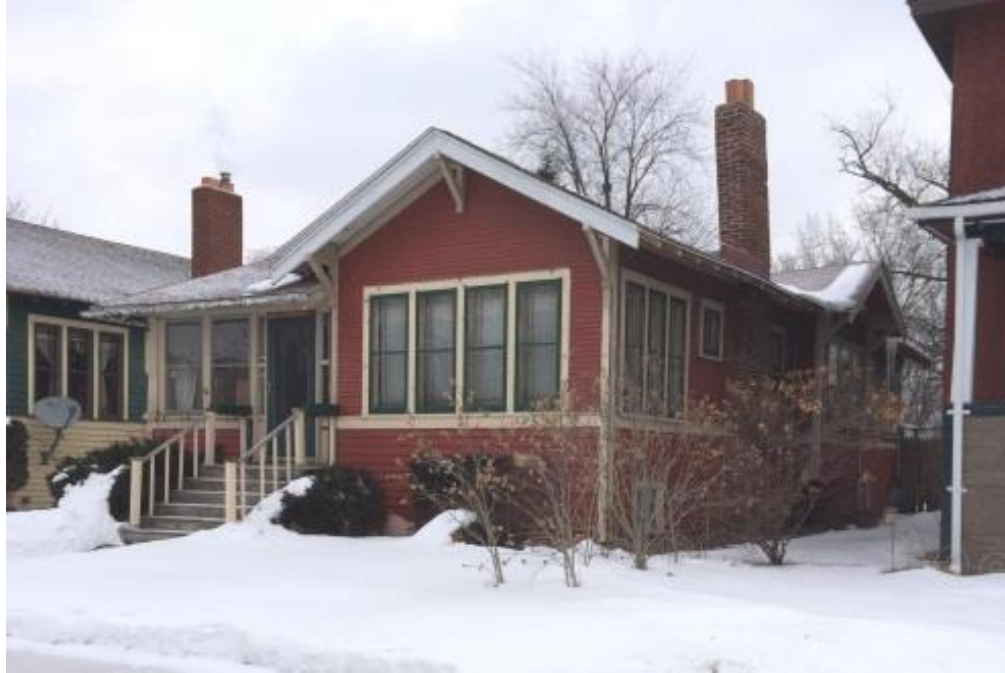
The house at 5967 Park Place was constructed in the Bungalow style in 1918 (**Figure 5-16**). The 1.5-story wood-framed residence has a front gable roof with exposed rafter ends and decorative wood brackets. The roof is sheathed with asphalt shingles.

**Figure 5-16: 5967 Park Place (view northeast)**

The residence has an asymmetrical façade formed by the offset gable roof porch. Windows are a mixture of 1/1 double-hung aluminum frame windows, wood frame 1/1 double-hung windows, and multi-light wood frame windows with removable two-light wood frame storm windows. The front entrance is a single entry door with one light framed by two, two-light sidelights. Wooden stairs with wood railings are used to access the front entrance. There is an exterior brick chimney and a cross gable roof feature on the south side of the residence.

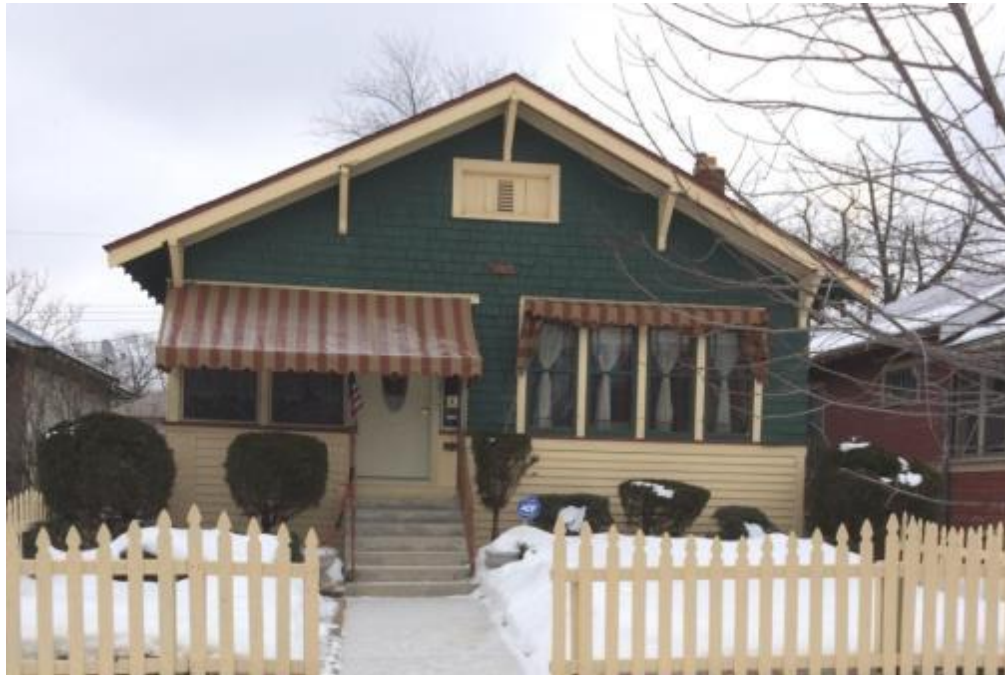
**Figure 5-17: 5963 Park Place (view east)**

The house at 5963 Park Place was constructed in the Bungalow style in 1917 (**Figure 5-17**). The 1.5-story wood-framed residence has a front gable roof with exposed rafter ends and decorative wood brackets. The roof cladding is asphalt shingles. A window opening in the gable end has been infilled with plywood and a metal vent.

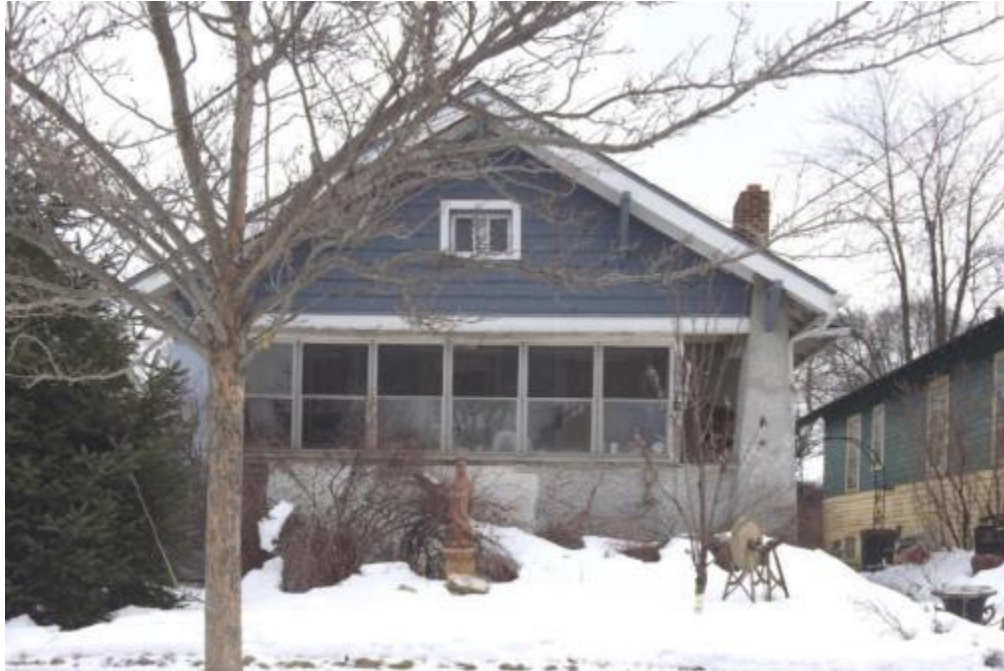
The house at 5959 Park Place was constructed in the Bungalow style in 1915 (**Figure 5-18**). The 1.5-story wood-framed residence faces west and has a front gable roof with decorative wood brackets. The front (west) portion of the roof has boxed eaves and the back (south) portion of the roof has exposed rafter ends. The roof cladding is asphalt shingles.

**Figure 5-18: 5959 Park Place (view east)**

There is a three-light wood-framed window with a wood surround on the gable end clad with painted wood shingles. The center window has been infilled with a vent. The exterior wall surface has been sheathed with stucco and the original front porch has been enclosed with aluminum-framed windows. A stairwell on the south side of the residence provides access to the porch and the front entrance. Other windows include 1/1 and 4/1 double-hung wood-framed windows and smaller, wood-framed awning windows. All windows have wood surrounds. There is an exterior brick chimney on the south side of the building, which has been sheathed with stucco below the roof line.

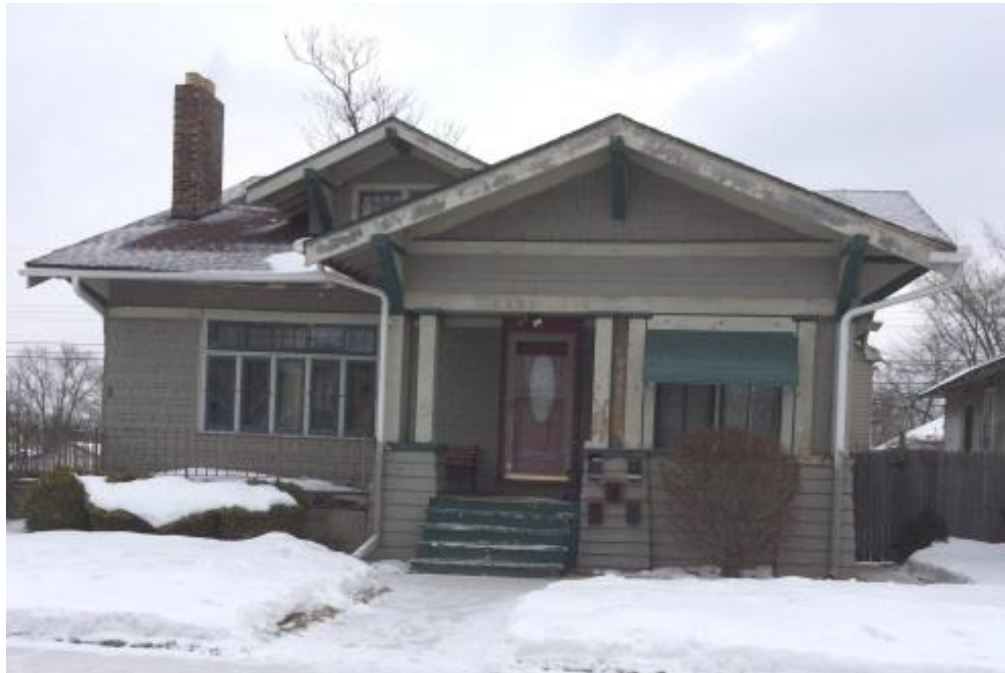
The house at 5957 Park Place was constructed in the Bungalow style in 1915 (**Figure 5-19**). The 1.5-story wood-framed residence faces west and has a cross gable roof clad with asphalt shingles with boxed eaves and decorative wood brackets.

**Figure 5-19: 5957 Park Place (view east)**

The north-south oriented, or side gable portion, has a gable roofed dormer with exposed rafter ends with a set of paired, wood-framed awning windows with wood surrounds. The east-west oriented or front gable portion of the house includes the front entrance, which is recessed and shaded by the overhanging roof with wood supports. The exterior wall surface is a combination of wood siding and asphalt roll designed to look like concrete block in a random bond.

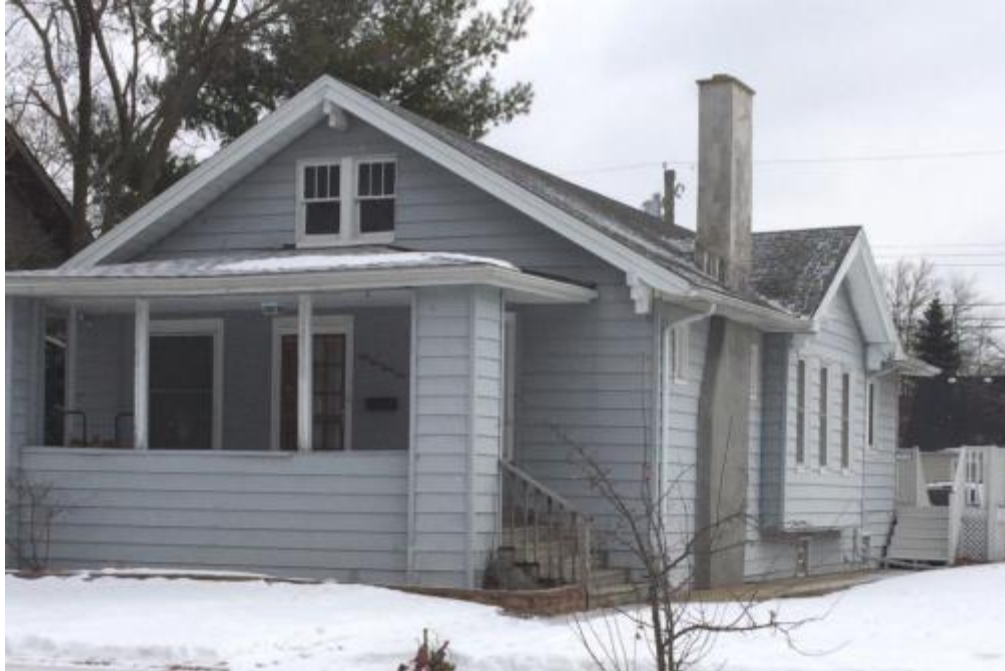
The house at 5949 Park Place was constructed in the Bungalow style in 1913 (**Figure 5-20**). The 1.5-story wood-framed residence faces west and has a front gable roof with decorative wood brackets. The roof is clad with asphalt shingles and has boxed eaves. There is a set of paired, 3/1 wood-frame double-hung windows with wood surrounds in the front gable end. A hipped roof shades the front porch. The porch piers and base of the porch have been covered with siding to match the rest of the house. The porch is accessed by a wood staircase on the south side of the porch. The central, multi-light wood-framed single entrance is framed by two multi-light 1/1 double-hung windows. There are gable-roofed bump outs on the north and south sides of the house. The south bump out has three 6/6 double-hung windows and a two-light window in the gable end. Other windows on the south side of the house include three-light fixed or awning windows and 6/6 double-hung windows. There is a porch on the back (east) of the house and an exterior chimney that has been sheathed in stucco on the south side.

**Figure 5-20: 5949 Park Place (view northeast)**

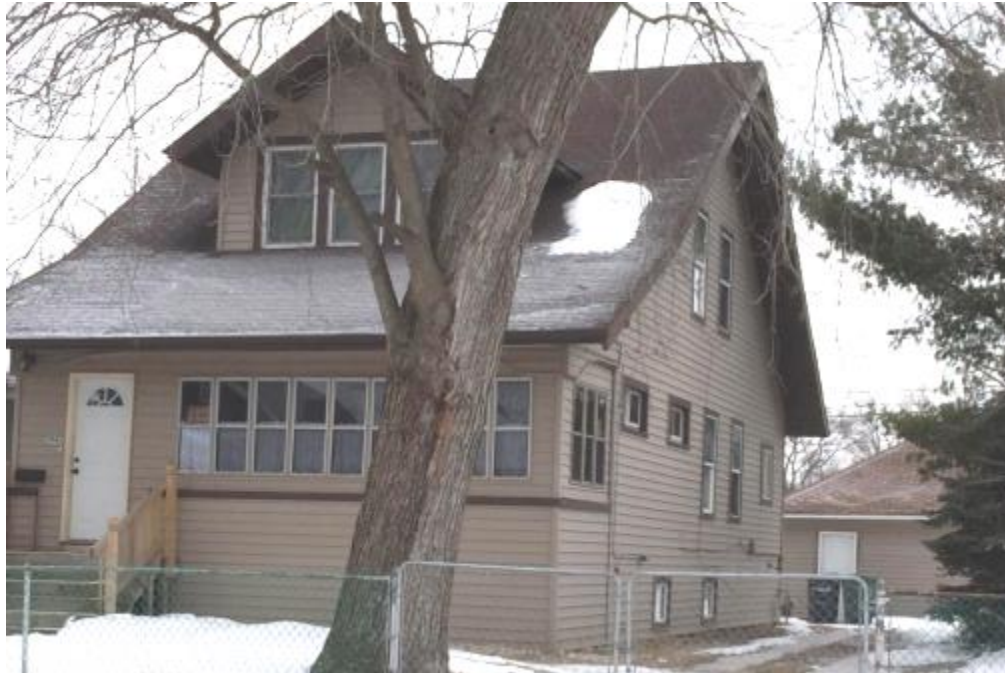
The house at 5945 Park Place was constructed in the Bungalow style in 1915 (**Figure 5-21**). The 1.5-story wood-framed residence faces west and has a side gable roof that extends to the west to form a shed roof porch that has been enclosed. There is a modern, paneled wood or vinyl door with a fan light and a set of nine 1/1 aluminum-framed windows on the front of the residence. The front door is accessed by a wooden staircase with wood railings. A large, front gable-roofed dormer is centered on the roof facing west with three 1/1 aluminum-framed windows with wood surrounds. Other windows include an original six-light window; small two-light sliding vinyl sliding windows; and 1/1 vinyl double-hung windows.

**Figure 5-21: 5945 Park Place (view northeast)**

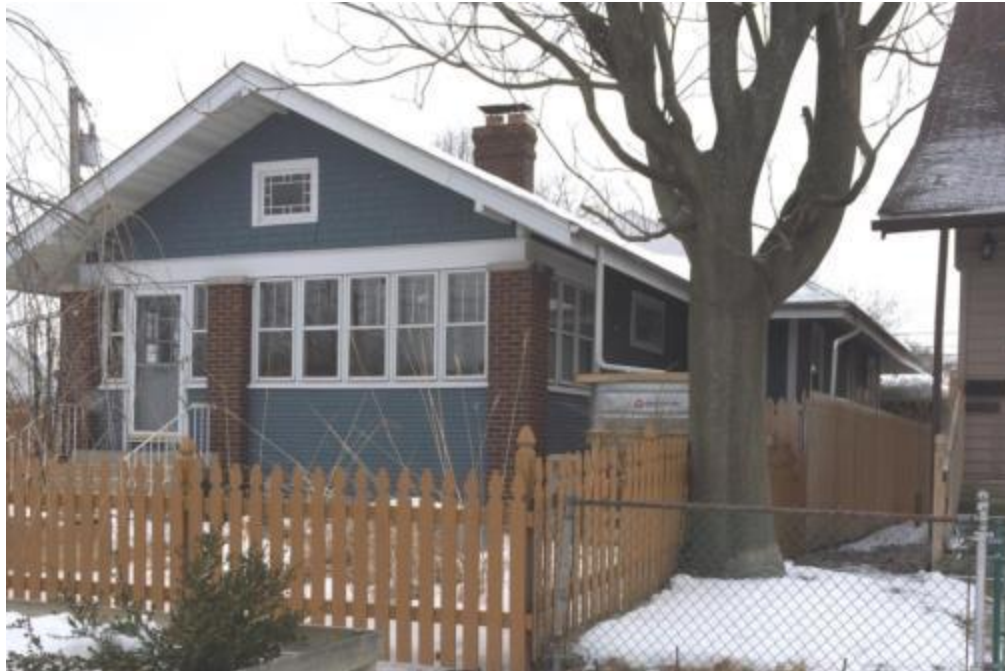
The house at 5943 Park Place was constructed in the Bungalow Style in 1915 (**Figure 5-22**). The 1.5-story wood-framed residence faces west. The front of the house has a front gable roof and the roof on the back of the house is hipped. The roof is clad with asphalt shingles and has boxed eaves. The gable end is faced with painted wood shingles and has a central multi-light window with a wood frame.

The gable roof originally extended out to form a porch overhang that was supported by brick piers. The porch has been infilled with a single entry paneled door with nine lights flanked by two-light sidelights, and a set of five 3/1 double-hung ribbon windows with wood surrounds. A set of three identical windows enclose the north and south sides of the porch. Concrete steps with metal railings provide access to the front entry. There is an interior chimney and a gable-roofed feature on the north side of the building.

**Figure 5-22: 5943 Park Place (view northeast)**

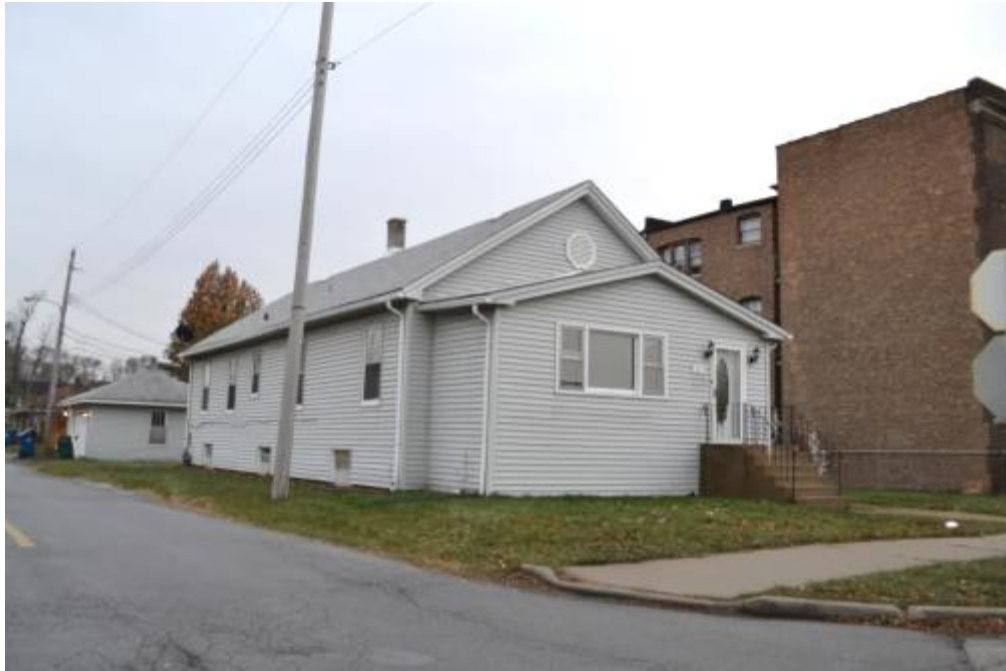
**Figure 5-23: 268 Waltham Street (view southwest)**

The house at 268 Waltham Street was constructed in the Bungalow style in 1916 (**Figure 5-23**). The one-story wood-framed residence faces north. The main portion of the house has a front gable roof with an octagon-shaped vent in the gable. The front entrance to the house is within an enclosed front porch with a shorter and lower-pitched roofline than the main portion of the house. The roof is clad with asphalt shingles and has boxed eaves.

The front windows include an aluminum-framed picture window with 1/1 aluminum-framed double-hung windows on each side. The front door is a modern vinyl or wood door with a large decorative oval light that is accessed by a concrete staircase with metal railings. Windows on the side of the house are 4/1 wood-frame double-hung windows and the basement windows are glass block. An interior chimney appears to be constructed of concrete block near the center of the ridge line. A three-sided canted bay window with a gable roof is on the west side of the residence.

Built in 1916, the house at 268 Waltham Street is representative of the growth of industry and the local economy in the early 20th century and the subsequent expansion of residential development south of the city center in the vicinity of Harrison Park. This was a common pattern for residential development in Hammond during that era, and the residence does not have significant associations to meet NRHP Criterion A. Research did not reveal any direct associations with important historical people and the house is not eligible for the NRHP under Criterion B. The house is a modest example of the Bungalow style, and the modifications to the original porch have resulted in a loss of integrity. The house is not eligible for the NRHP under Criterion C. The property dates to the 1910s, and its history is documentable. It is not likely to yield further information about history to meet Criterion D.

In summary, the property does not meet the NRHP criteria, and it is not individually eligible for listing in the NRHP. In addition, the house does not retain sufficient integrity to be considered potentially eligible as a contributing property to the Harrison Park Historic District.

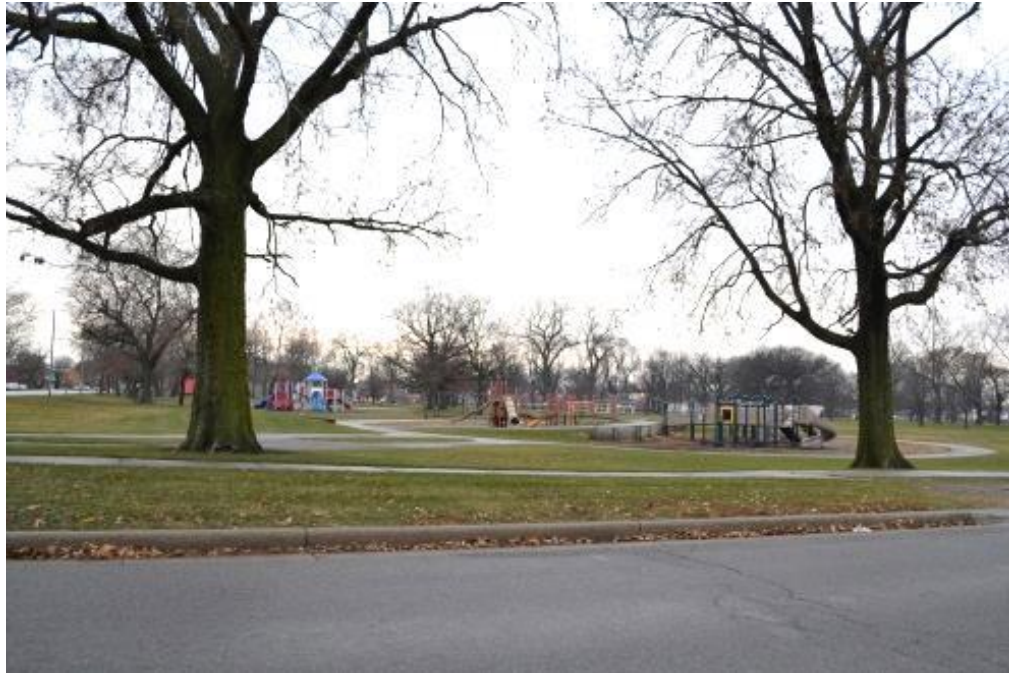
**Figure 5-24: Harrison Park Playgrounds (view north from Waltham Street)**

Harrison Park is an urban park that encompasses approximately 24 acres bounded by Lyman Avenue to the east, Hohman Avenue to the west, Webb Street to the north, and Waltham Street to the south (**Figure 5-24**). The park contains paved walkways, picnic areas, utility sheds, tennis courts, assembly areas, a surface parking lot, and modern playground structures. Its main feature is a manmade lagoon located in the center of the park. Trees are sparsely spaced across open lawn. Structures are constructed of concrete block and cast stone (**Figure 5-25**).
