# **Appendix B. Section 106 Consultation**

# Historic Property Report

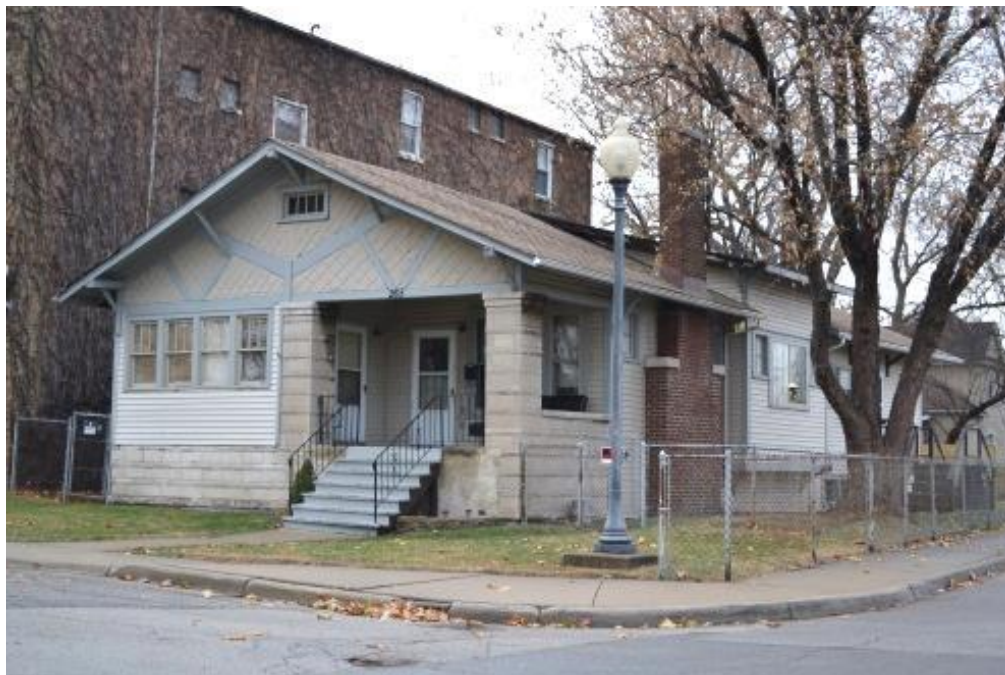
**Figure 5-27: 265 Webb Street (view southwest)**

The building at 265 Webb Street is a Bungalow-style residence constructed in 1913 (Figure 5-27). The one-story, wood-framed house faces south. The front gable roof is clad with

asphalt shingles and has decorative brackets below the eaves. The front gable end is faced with diamond-shaped shingles and faux half-timber battens. There is a four-light, wood-framed awning window with a wood surround in the peak of the gable end. The front porch is constructed of concrete block with an alternating bond of 8-inch concrete block and 4-inch rusticated concrete block. The roof of the house extends to form the porch roof. The porch is accessed by a set of wooden stairs with metal railings. The primary entrance is a single entry wood door with nine lights with a metal screen door. There are two 1/1 double-hung wood-framed windows adjacent to the door. It appears that one bay of the two-bay porch was infilled as a room. The infill includes a set of four historic 3/1 double-hung wood-frame in windows, indicating the infill was constructed during the historic period or the windows were taken from elsewhere in the house or salvaged from another property. A door was installed in the east wall, perpendicular to the primary entrance. Other windows include 1/1 double-hung and sliding vinyl windows, four-light wood frame awning windows, and 4/1 double-hung wood frame windows. Basement windows appear to be one-light fixed or awning windows. There is one interior brick chimney and one exterior brick chimney on the east side of the house, as well as a bump out with a shed roof.

In summary, the property does not meet the NRHP criteria, and it is not individually eligible for listing in the NRHP. However, the house retains sufficient integrity to be considered potentially eligible as a contributing property to the Harrison Park Historic District.

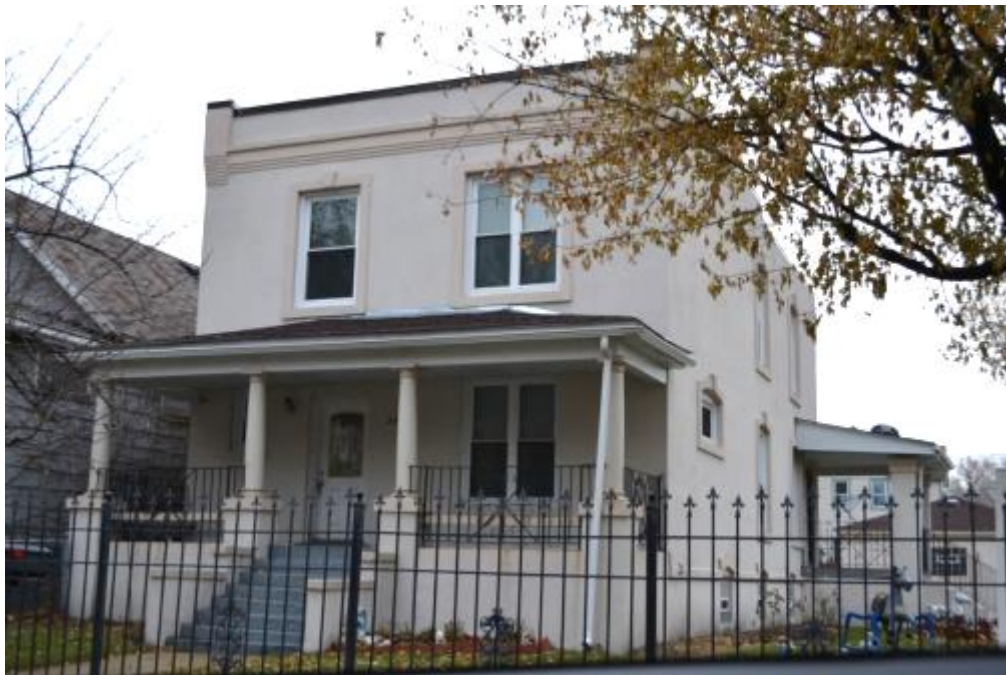
**Figure 5-28: 255-257 Carroll Street (view northwest)**

The building at 255-257 Carroll Street is a two-story Chicago two-flat duplex with Neoclassical-style characteristics constructed in 1907 (**Figure 5-28**). The original brick has been sheathed with stucco. The roof is flat with a parapet wall. The entrance on the front (south) of the building is shaded by a hipped roof porch supported by wood Doric columns and brick piers. The porch is accessed by a central staircase. The door is a modern paneled door with a decorative light. There is one small 1/1 double-hung wood-frame window on the west side of the door and a set of paired 1/1 double-hung wood-frame windows on the east side of the door. Windows on the front of the building on the second level include three 1/1 double-hung wood-frame windows (one single and one set paired). There is a cascading stringcourse above the second floor windows below the parapet wall. The windows on the front of the duplex have wood keystones and surrounds.

There is another entrance on the east side of the building, which is shaded by a shed roof porch that is supported by brick and stucco piers and wraps around the north side of the building. The east entry is a metal security door. Windows on the east side of the building are 1/1 double-hung windows and two-light sliding windows with arched keystone lintels and surrounds. The basement windows are narrow awning or fixed windows surrounded by fixed glass blocks. There is an associated, free-standing garage with a hipped roof to the north of the building.

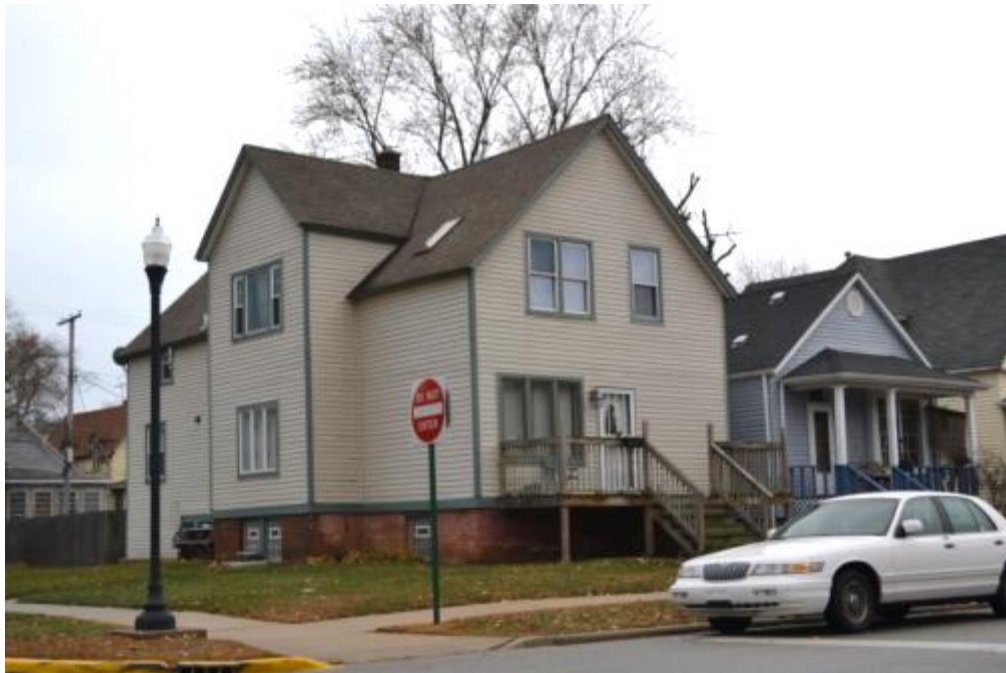
**Figure 5-29: 256 Williams Street (view southwest)**

The house at 256 Williams Street was constructed in the vernacular gable-front style in 1900 (**Figure 5-29**). The two-story residence faces north and has a brick foundation. The roof is clad with asphalt shingles and there is a brick interior chimney near the center of the ridgeline. Windows on the front of the house include a set of three fixed or casement ribbon windows and there are three 1/1 double-hung windows (one single and one set paired) on the second level. The primary entrance is a single entry vinyl or wood door with a metal and glass security door. A wooden staircase and deck with wood railings provide access to the front door. Windows on the sides and rear of the house are 1/1 and 4/4 double-hung windows. The east side of the house has a cross gable bump out wing that includes a set of three fixed and casement ribbon windows on the first level and a picture window framed by two 4/1 double-hung windows. The basement windows are narrow awning or fixed windows surrounded by fixed glass blocks.

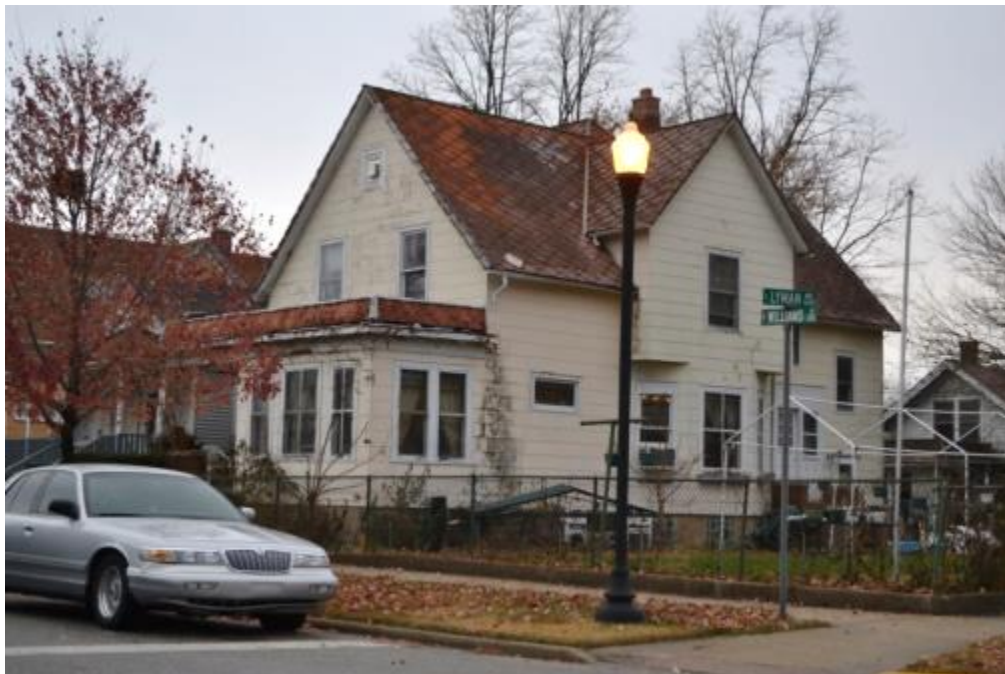
**Figure 5-30: 253 Williams Street (view northwest)**

The house at 253 Williams Street was constructed in the vernacular Gable-front style in 1911 (**Figure 5-30**). The two-story residence faces south. The cross-gable roof is steeply pitched and is clad with large diamond-shaped shingles. There is a two-bay, one-story wing on the front of the house with a flat roof and a short parapet wall that is faced with the diamond-shaped shingles. One bay of the one-story wing includes living space and the other bay is a recessed front porch. The porch overhang is supported by a tapered wood pier with a brick base and is accessed by a concrete staircase. The front entry is a wood, single entry door with 15 lights. Windows on the front of the residence include one-light fixed stained glass window, two- and four-light wood-framed awning windows, and 1/1 double-hung windows. There is an attic vent in the gable end. All windows and the vent opening have wood surrounds. The cross gable section on the east side of the house is two stories. The lower story is a canted bay window and the upper story is a rectangular bump out with one window. The windows on the east side of the house include a horizontal awning window, 1/1 double-hung windows, and a four-light double-hung or fixed window. Basement windows are fixed glass block. The back and west side of the residence were not visible from the public ROW.

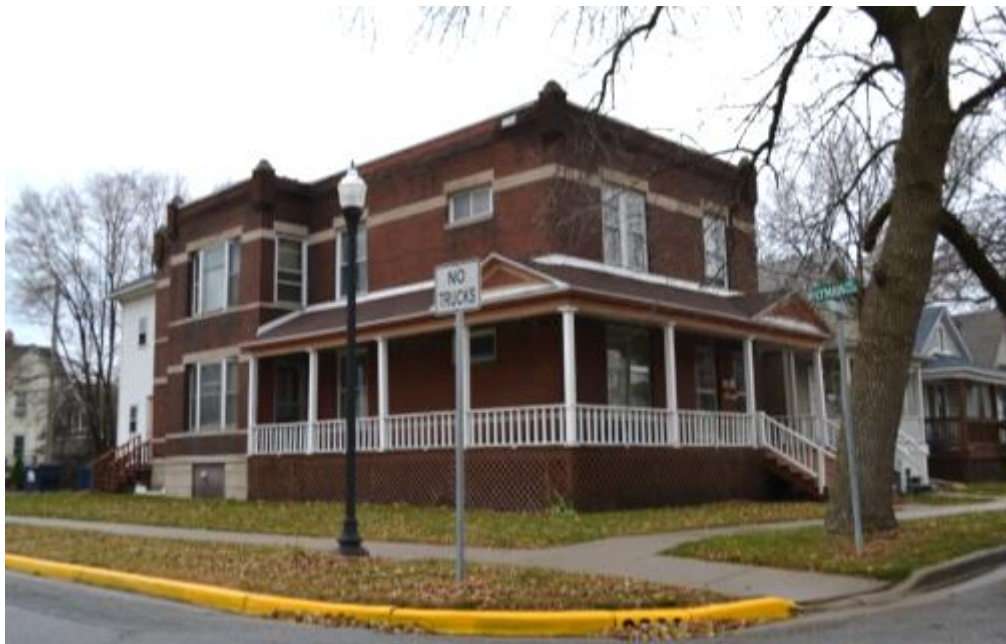
Figure 5-31: 256 Doty Street (view southwest)

The building at 256 Doty Street is a two-story Chicago two-flat duplex constructed in 1907 (Figure 5-31). The brick building faces north and the roof is flat with a parapet wall and patterned brick cornices. A one-story, shed-roofed porch wraps around the front and a portion of the east side of the building. The porch roof is clad with asphalt shingles and there are triangular pediments above the front (north) entry and on the northeast corner. The porch roof is supported by wood posts and is accessed by a staircase with wood railings that continue around the perimeter of the porch. The porch is raised off of the ground and the space between the porch and the ground surface is screened by wood lattice. There are two adjacent single entry doors on the front of the duplex, which are wood or vinyl with one light and protected by aluminum and glass storm doors. There is a set of paired double-hung aluminum-framed windows adjacent to the doorways. Windows on the second floor on the front of the building include a set of paired vinyl-framed double-hung windows and a single double-hung window. The second floor windows have stone lintels that match a stone stringcourse that continues around the east side of the building. The east side of the building features a two-story bump out with bay windows. There is two-story wood frame addition with a brick foundation on the back (south) of the duplex with a mansard roof. Windows in the addition are 1/1 double-hung windows and doors appear to be utilitarian wood or metal single entry doors.

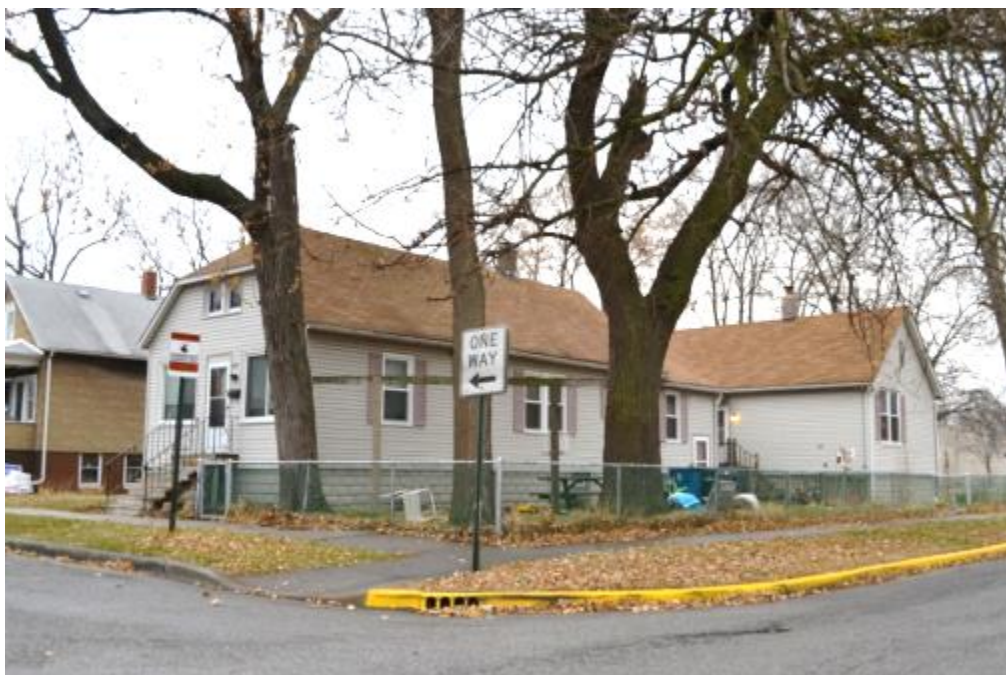
**Figure 5-32: 255 Doty Street (view northwest)**

The house at 255 Doty Street was constructed in the vernacular Gable-front style in 1907 (**Figure 5-32**). The wood frame building faces south and has a raised masonry foundation. The front gable roof is a hipped gable or jerkinhead and is clad with asphalt shingles. The front of the house has a modern single-entry door with sets of paired two-light sliding windows on either side of the door. There is a smaller, horizontal, two-light sliding window in the gable end. The front entry is accessed by wood steps with metal railings. The house may have originally had a front porch that was later enclosed. Windows on the east side of the house are 1/1 double-hung or two-light sliding windows with faux wood shutters, and windows on the west side are 1/1 double-hung windows. Basement windows are narrow awning or fixed windows surrounded by fixed glass blocks. There is an interior brick chimney near the ridgeline toward the back of the house. There is a smaller, free standing, gable-roofed wood frame residence on the back of the parcel that was constructed using materials similar to those used to construct the main residence.

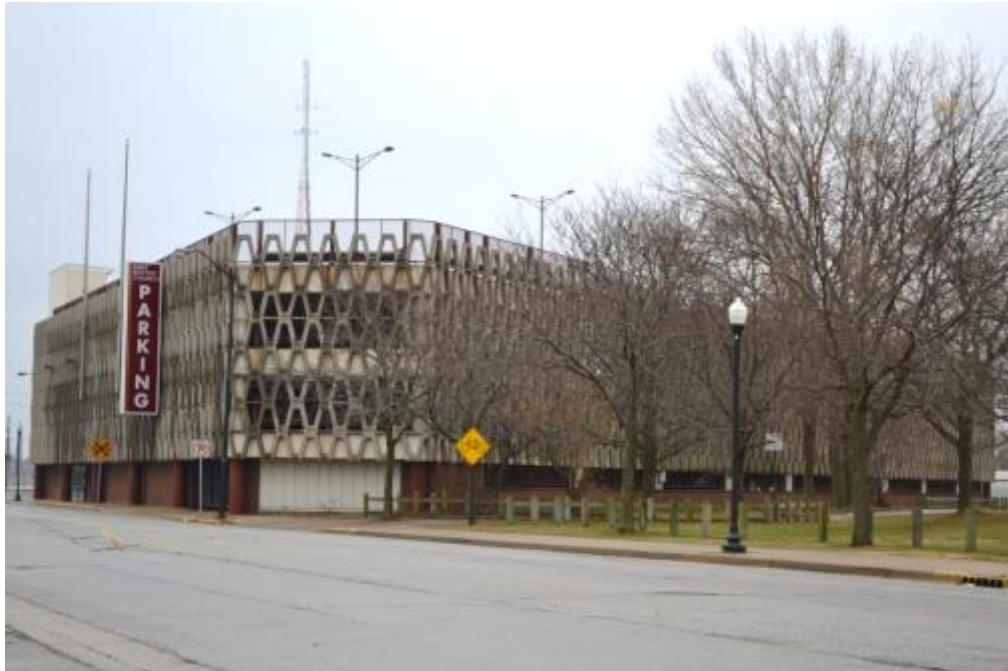
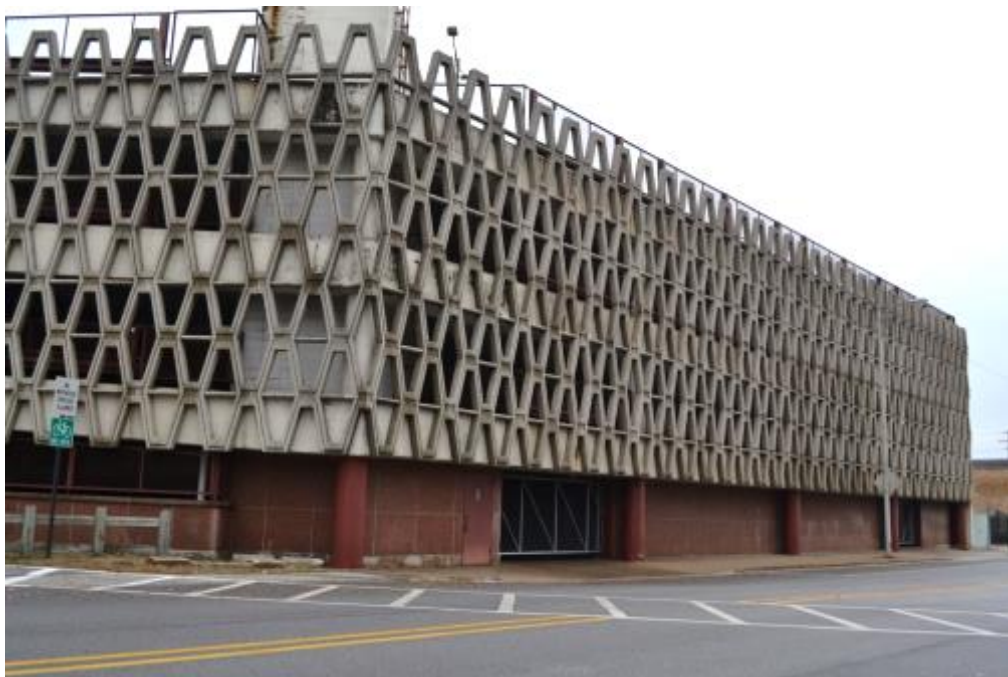
The exterior of the Minas Parking Garage retains much of its original appearance and no major alterations were observed. The building retains its location, design, workmanship, materials, association, setting, and feeling and is eligible for the NRHP under Criterion C.

**Figure 5-34: Minas Parking Garage, North and West Sides (view southeast)**

**Figure 5-35: Minas Parking Garage, West and South Sides (view southeast)**

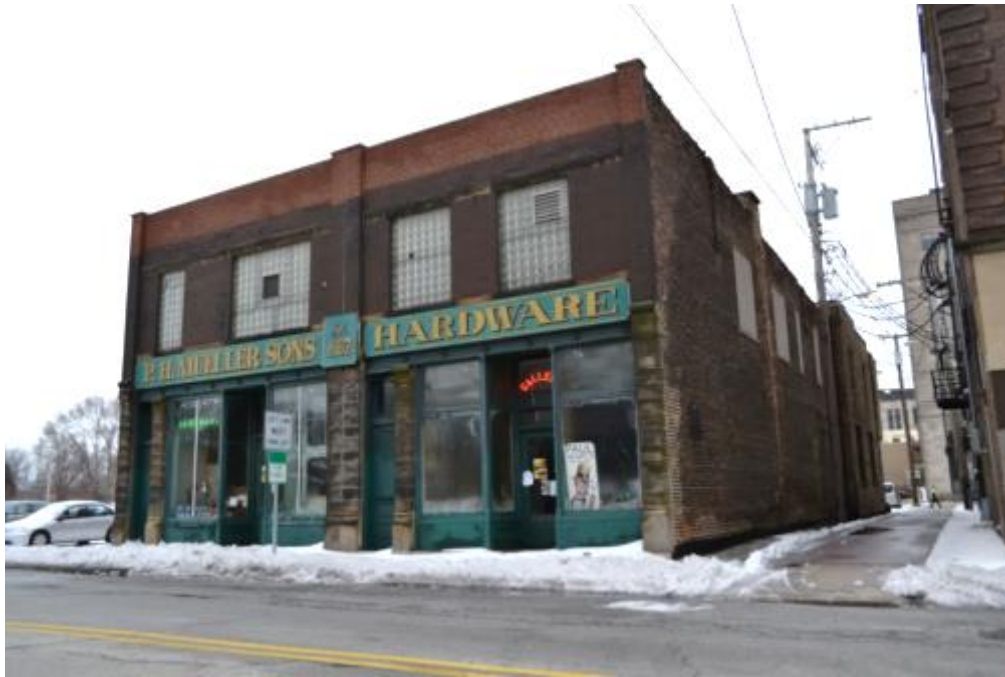
**Figure 5-36: 416-418 Sibley Street (view south)**

The P.H. Mueller Sons Hardware building at 416-418 Sibley Street is an early 20th century commercial building constructed in 1902 (**Figure 5-36**). Paul Henry Mueller opened his first

The P.H. Mueller Sons Hardware building faces northeast and is two bays wide. Each bay includes a storefront on the first floor and two windows on the second floor. Brick pilasters define the vertical boundaries of the two bays, and stone facing applied to pilasters on the first floor frames the first floor store fronts. Signage provides a horizontal visual separation between the first and second floors. The two storefronts are identical and include recessed doorways between two-sided display windows. There are single entry side doors adjacent to both storefronts that provide stairway access to the second floor. There are transoms above each of the doors and windows and panels below the first floor windows. The original four windows on the second story have been removed and replaced with fixed glass blocks. Window openings on the sides of the building all appear to have been infilled or covered with plywood.

The original second story windows have been replaced with fixed glass blocks and windows on the sides have been infilled or covered with plywood. Despite these alterations, the building retains its location, design, workmanship, materials, association, setting, and feeling. Therefore, this property is eligible for the NRHP under Criterion A.

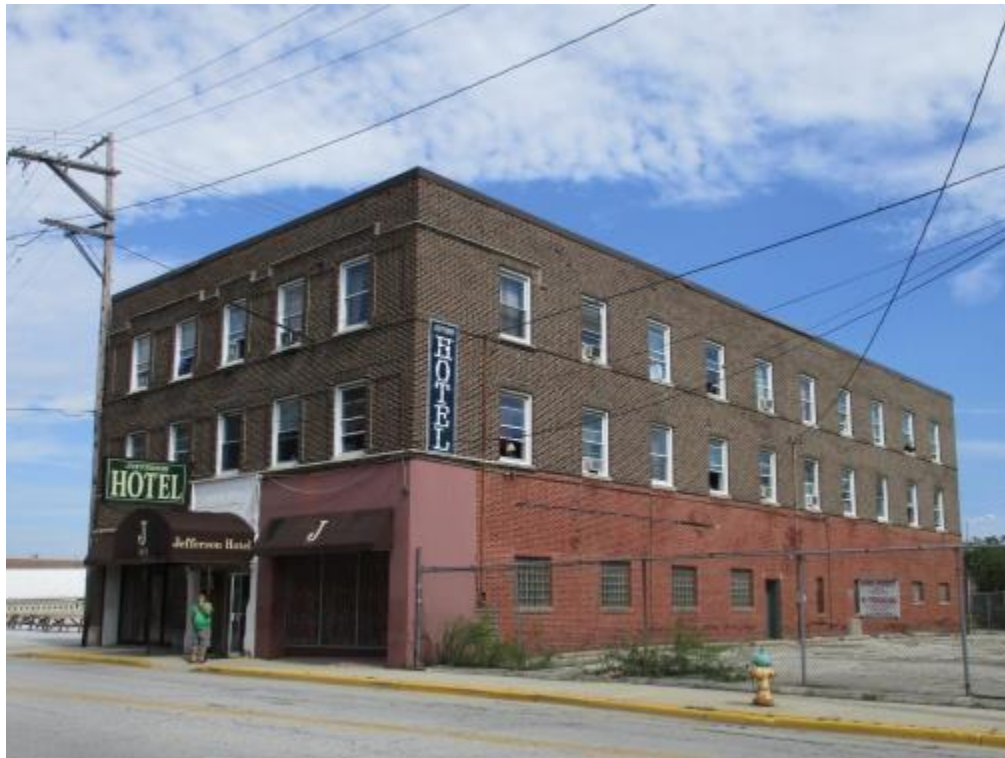
**Figure 5-37: Hotel Hammond (view north)**

The original windows have been replaced with modern 1/1 sash, glass block windows have been installed in the first story on the east side of the building, and the storefronts have been modified. Despite these alterations, the building retains its location, design, workmanship, materials, association, setting, and feeling. Therefore, this property is eligible for the NRHP under Criterion A.

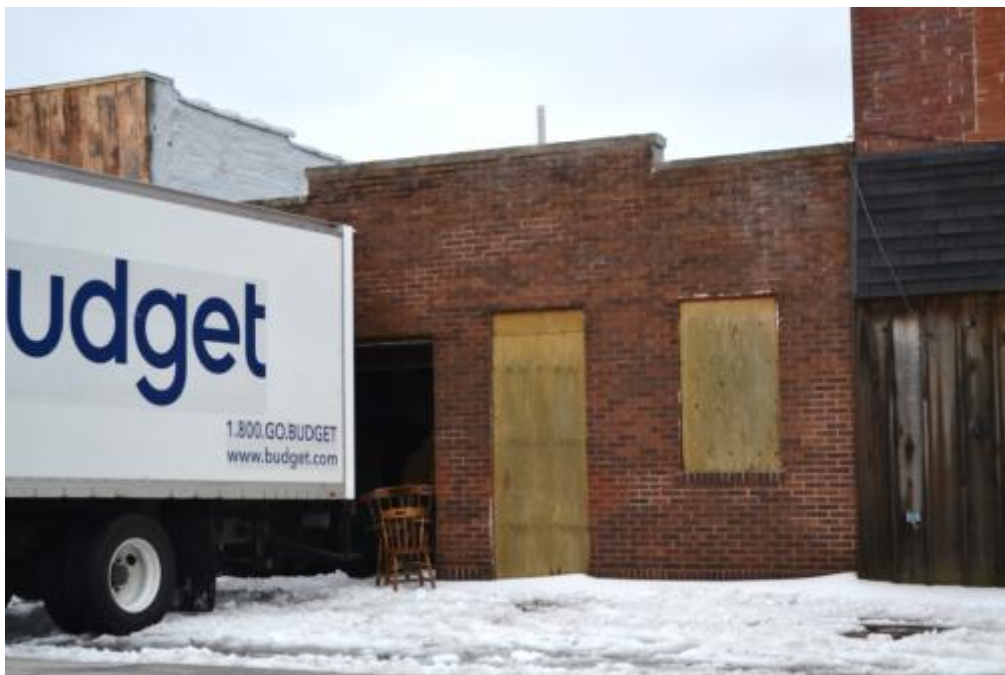
**Figure 5-38: 424 Willow Court (view south)**

The commercial building at 424 Willow Court is a one-story commercial vernacular building constructed in 1907 (**Figure 5-38**). The brick building has a flat roof with a stepped parapet wall. The side of the building that faces northeast toward Willow Court and the railroad tracks has a small window opening with a brick sill and a single-entry pedestrian door that have been boarded over. There also is a one-bay vehicle door with a modern, metal or vinyl roll-up door. The southwest side of the building, which appears to have been the original primary façade, also has a stepped parapet wall, two large storefront window openings that are boarded over, and a single entry door. There also is a rectangular, recessed area with a brick surround above the windows and door that likely originally featured signage. The commercial building is located between two other buildings and the northwest and southeast sides are not visible. The original structural brick on the southwest façade has been sheathed with stucco to match the façades of the adjacent buildings, which appear to be currently operating as one business property (**Figure 5-39**).

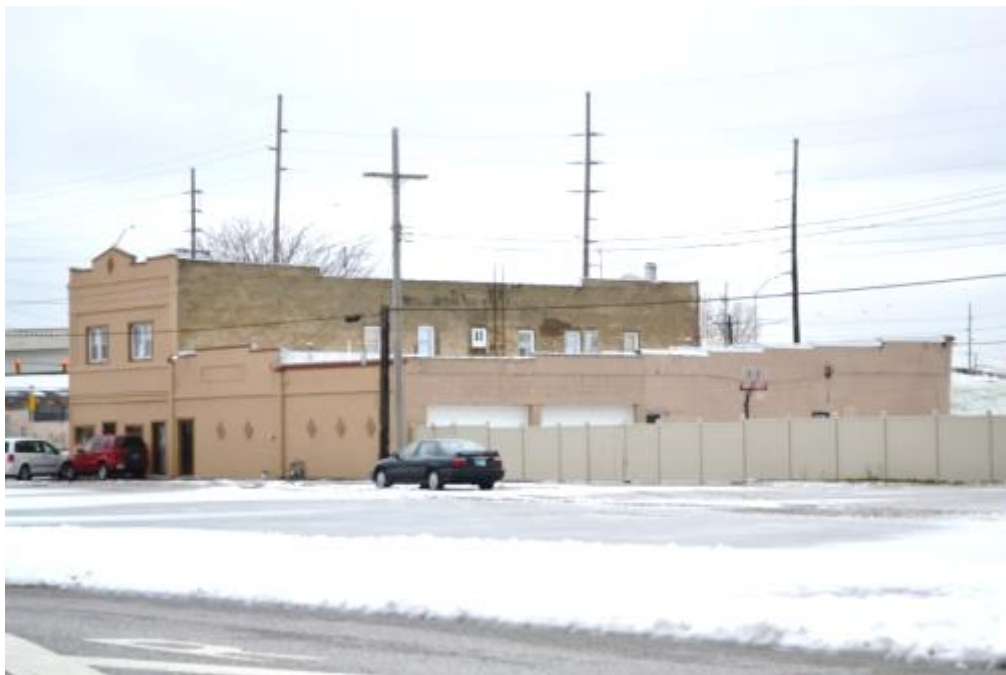
This commercial building was previously inventoried and determined to be a contributor to the State Street Commercial Historic District. This district, which includes properties on both sides of State Street between Sohl and Bulletin Avenues, is a cohesive example of downtown Hammond commercial development between 1885 and 1940. The buildings within the district are also a good representation of early 20th century commercial architecture (Clark 1998). State Street Commercial Historic District was listed in the NRHP under Criteria A and C in 1999. A review of photographs taken for the NRHP nomination in 1998 indicate that the stucco sheathing on the exterior of the southwest façade was added after the district was listed. However, the northeast side of the building that faces toward Willow Court is mostly unchanged since the 1998 recording, and the building retains its original massing. Therefore, the building appears to retain sufficient integrity to remain a contributing property to the State Street Commercial Historic District.

**Figure 5-39: Stucco Sheathing on southwest sides of 424 and 422 Willow Court (view northwest)**

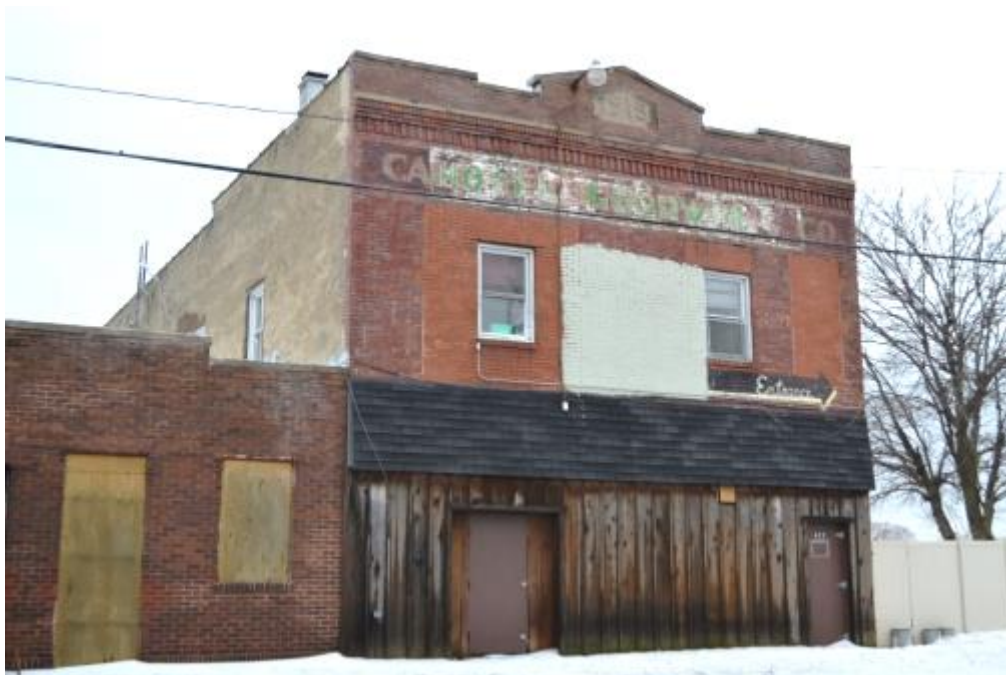
**Figure 5-40: Northeast Side of 422 Willow Court (view west)**

The building at 422 Willow Court is a two-story commercial vernacular building adjacent to 424 Willow Court (**Figure 5-40**). The brick building was constructed in 1915 and has a flat roof with parapets. The northeast and southwest parapet walls both have central pediments. Stone panels placed in the apexes of the pediments identify the year of construction. The cornice on the northeast side of the building features a concrete or stone band course and a brick dentil frieze. Original window openings on the second story of the northwest façade have been infilled with brick and replaced by two 1/1 double-hung aluminum-framed windows, and the exterior wall surface on the first floor has been covered with wood board and batten siding and asphalt

shingles. There also are two modern metal or wood single entry doors on this side of the building.

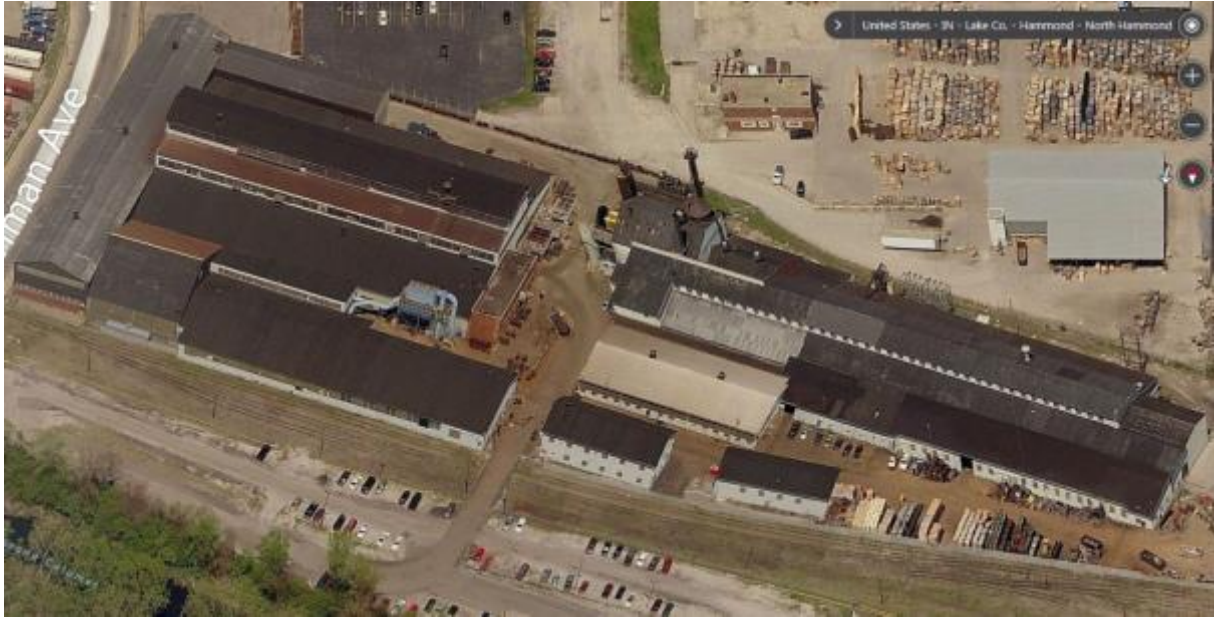
**Figure 5-42: Bing Maps Bird’s Eye View of 4831 Hohman Avenue circa 2005**

The building that is most visible from the public ROW is the structure immediately adjacent to Hohman Avenue. Historic aerial photographs indicate that this building was not constructed until the early 1960s (**Figure 5-44**). The broad side of this rectangular building is oriented perpendicular to the buildings on the property and conceals the west façades of several older buildings. The building has a concrete foundation and a pitched roof. The lower quarter of the building is constructed of brick and the rest of the building is constructed of prefabricated steel with corrugated metal exterior walls. An aerial photograph taken circa 2005 indicates the lower brick and upper steel portions of the building were originally separated by a line of ribbon windows and that the corrugated steel exterior wall cladding is a relatively recent addition (see **Figure 5-42**).

The company was founded in 1898 and some of the buildings on the parcel may date to that time period. The earliest construction year documented for the parcel by the Lake County Assessor is 1903. Historic aerial photographs indicate that most of the extant buildings were in place in 1939. The buildings within the industrial complex are long, rectangular structures that parallel the river. The short ends of a majority of the buildings face northwest, toward Hohman Avenue. A paved parking lot and a landscaped area are located between the river bank and the Simplex buildings. Aerial photographs indicate that the old railroad spurs remained extant in the vicinity of the landscaped and parking areas as late as 2005 (**Figures 5-42 and 5-43**).

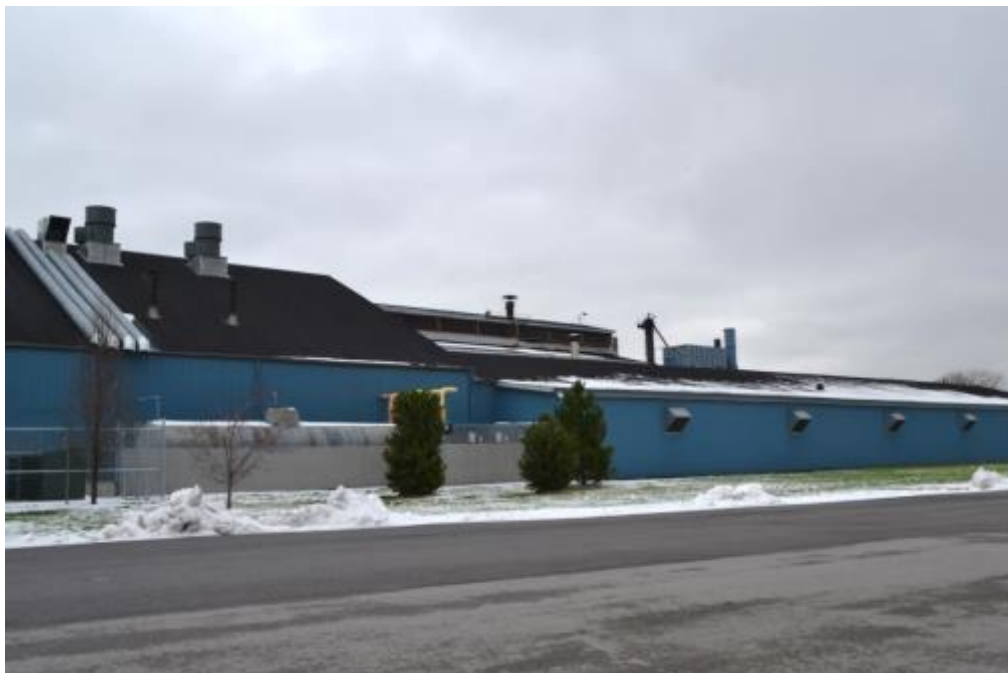
**Figure 5-45: Sides of Original Buildings with New Corrugated Steel (view northeast)**

Other buildings within the Simplex property likely are constructed of concrete, brick, steel, and wood. Most of the roof lines appear to be gabled or flat with monitors. Circa 2005 aerial photography indicates that the southwest exterior walls of the two buildings adjacent to the 1960s building also have been recently clad with corrugated steel (**Figure 5-45**, see **Figures 5-39** and **5-41**). The northeast walls of the buildings appear to retain their original appearance. Windows visible from the public ROW included steel-framed 15-light windows. Other historic structures visible on the property include a concrete smoke stack, a water tower, and other steel structures (**Figure 5-46**).

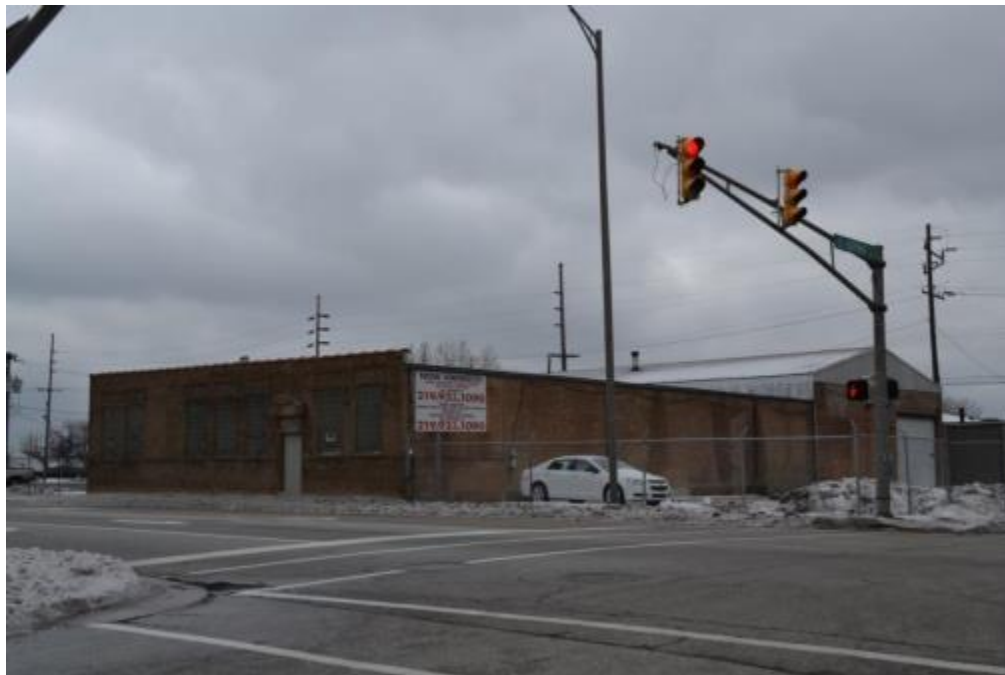
**Figure 5-47: “L” Shaped, One-story, Brick Aldobilt Building (view southwest)**

One of the buildings is an L-shaped, one-story brick building with a concrete foundation (**Figure 5-47**). One portion of the roof is flat with parapets and another portion has a gable roof. The gable roof is constructed of more modern materials than the rest of the building and is a later addition to the original flat roof. The east side of this vernacular commercial/light industrial building has the most architectural detailing and may have once served as the primary or secondary entrance. The seven fixed glass block windows on this elevation are located above a rowlock brick band course. The windows are surrounded by brick frames constructed in a combination of bond patterns. There also is a decorative brick course along the base of the building above the foundation wall. The single-entry metal door also is framed by brick courses and has a pediment. Numerous window and door openings have been infilled on the north side of the building. The only opening that remains extant is a large vehicle bay opening.

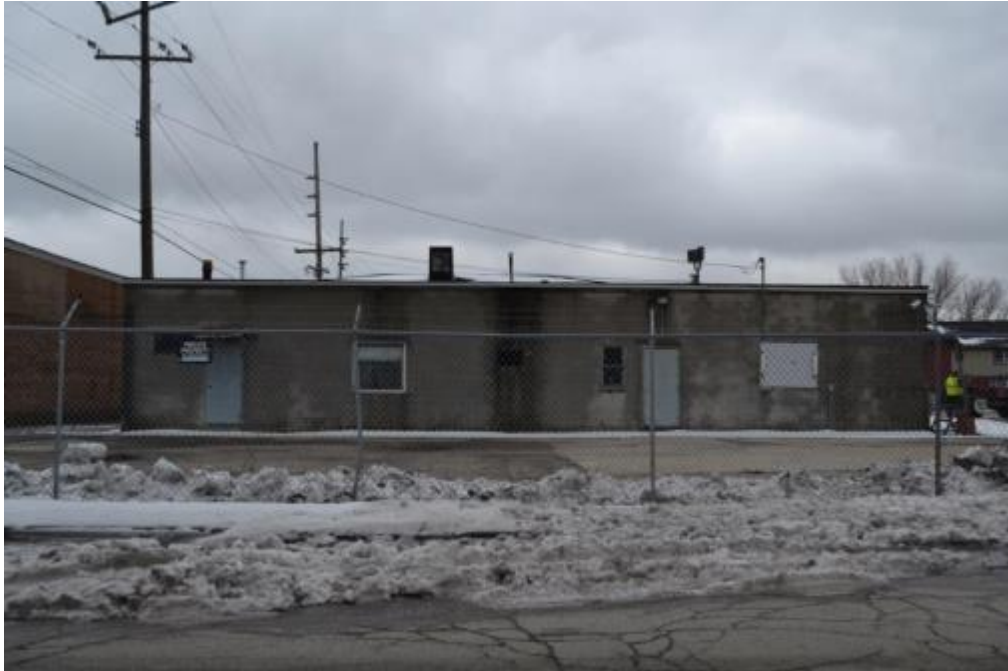
**Figure 5-48: Concrete Block Aldobilt Building (view south)**

Another building on the parcel is a structure with a hipped roof with a flat roof addition (**Figure 5-48**). The addition is utilitarian and constructed of concrete block. The hipped roof portion of the building may be constructed of wood frame, but it was not fully visible from the public ROW. Historic aerial photographs indicate this building was substantially reduced in size in the 1970s or 1980s.

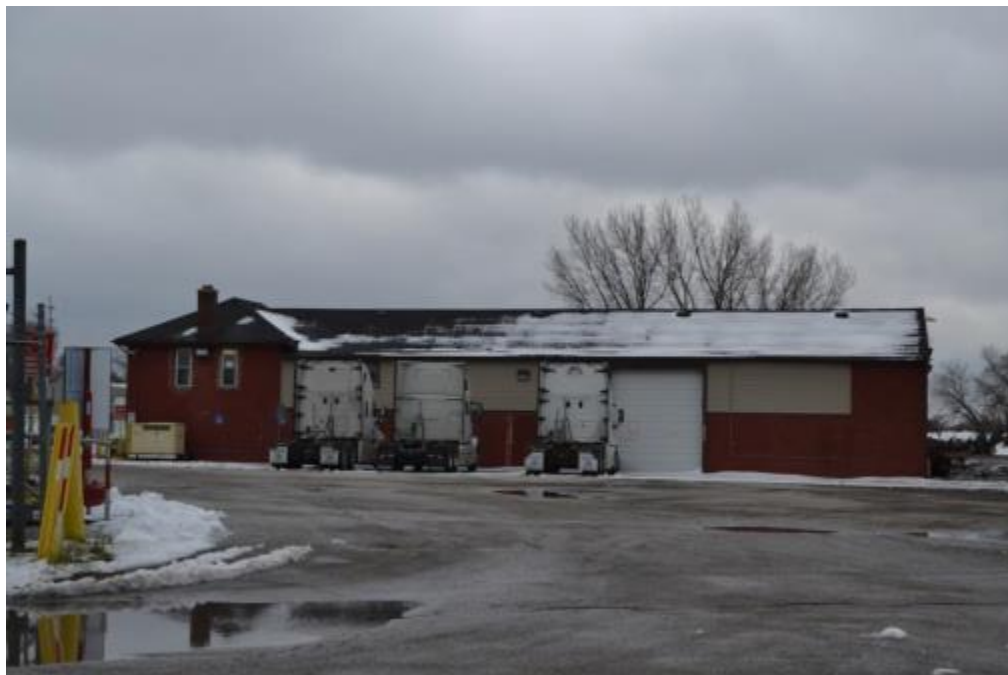
**Figure 5-49: Office/Warehouse Building (view southwest)**

The third building appears to be an office with an attached warehouse/garage (**Figure 5-49**). The building is constructed of brick and wood framing. The office portion of the building has a hipped roof and 1/1 double-hung windows and the warehouse/garage portion has a side gable roof and a vehicle bay with a roll-up door.

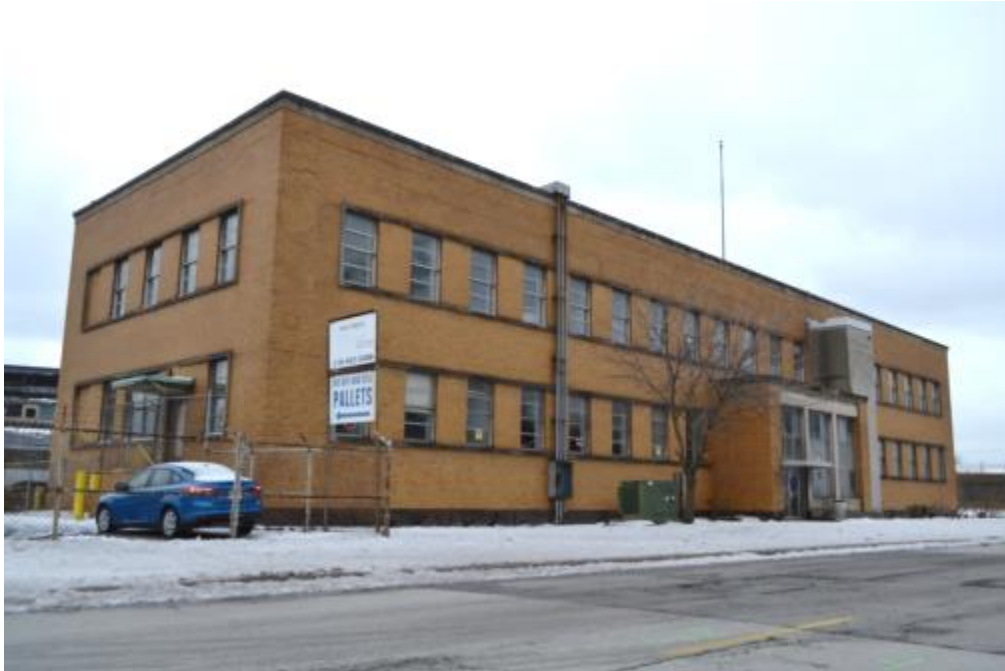
**Figure 5-50: Office Building at 420 Hoffman Street (view southwest)**

The property at 420 Hoffman Street is a single tenant office building constructed by the State of Indiana in 1953 (**Figure 5-50**). The last known tenant of the building was the State Family and Social Services Administration. The building currently is privately owned. The steel frame and brick International style building is two stories tall with a one-story rooftop penthouse. The roof is flat with parapets and the foundation is concrete. The building has a rectangular, horizontal footprint with a low, squared, geometric massing. All four elevations of the building feature two regularly spaced rows of steel or aluminum-framed 2/2 double-hung windows. The rows of windows are framed by concrete bands.

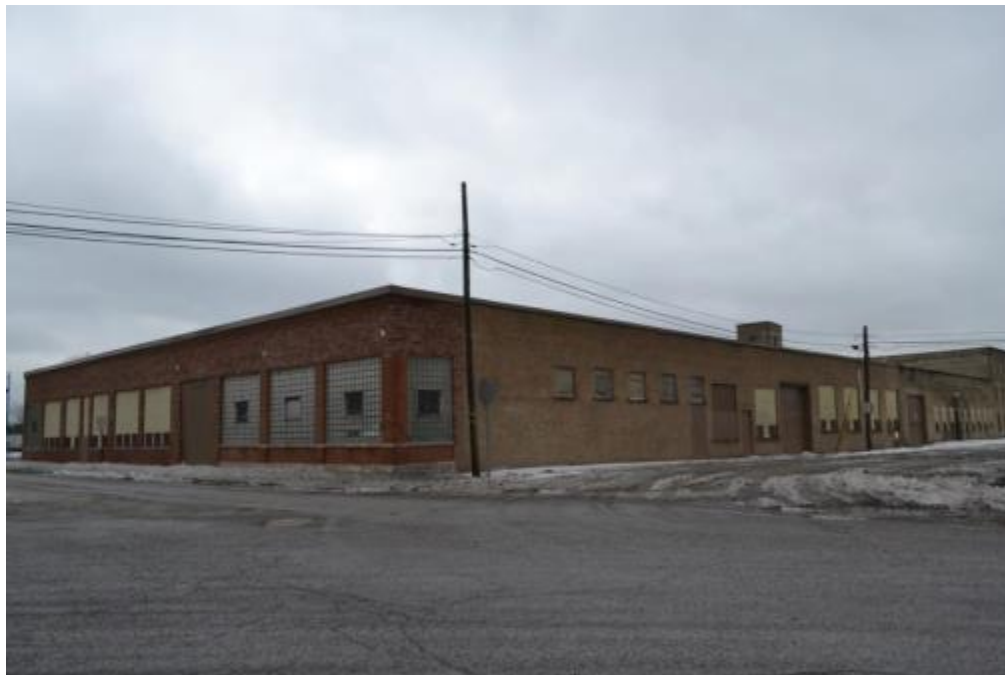
**Figure 5-52: One-story Section of the O.K. Champion Building (view southwest)**

The first section of the building to be constructed was the one-story machine shop, which was constructed in 1905 (Howat 1915; **Figure 5-52**). Sanborn Fire Insurance Maps indicate that by 1930 the one-story section housed an office, machine and welding shop, body service shop, and auto body factory. The map indicates that this section is constructed with steel columns and berms and has a concrete floor. Interiors are lit by numerous wire glass skylights. The façade that faces east toward Sheffield Avenue once served as the public entrance and is the only side of the building that possesses any architectural detail. The east façade and the northeast corner are constructed of red brick. Large square window openings are located on the northeast corner and across the east elevation. The northeast window and three of the east windows have brick sills and recessed base panels and have been infilled with small fixed aluminum-framed windows and fixed glass blocks. Five other windows on the east side have brick sills. Four are metal-framed, multi-light windows that have been partially covered with corrugated metal and the fifth infilled with an aluminum-framed window and glass blocks. The storefront entrance has been covered with sheet metal. The rest of the one-story portion of the building is constructed with blond brick and poured concrete. Window openings are square with red brick sills. Some windows are similar to the metal-framed, multi-light windows on the east side of the building and some have small square openings. All windows have been fully or partially covered with sheet metal or plywood. The entrances are utilitarian single-entry doors or roll-up vehicle doors.

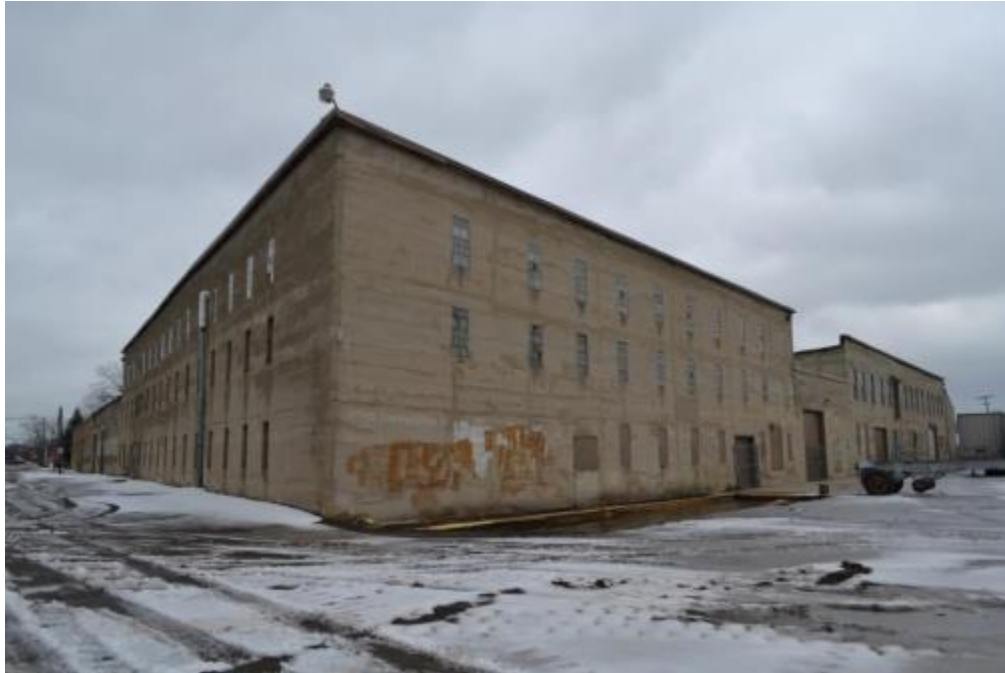
**Figure 5-53: Three-story Section of the O.K. Champion Building (view southeast)**

The three-story section of the building, which is located west of the one-story section, served as storage and was constructed in 1914 (Howat 1915; **Figure 5-53**). O.K. Champion stored parts, chemicals, and lumber on the first floor and farm machinery on the second and third floors. This section of the building is constructed of steel columns of poured concrete, with board forms remaining visible on the exterior wall surfaces. Most of the regularly-spaced window openings are filled with glass blocks, but some are narrow 1/1 double-hung windows. Some windows and doors on the first story have been covered with sheet metal. This section of the building also has a large interior chimney or tower used to ventilate a kiln.

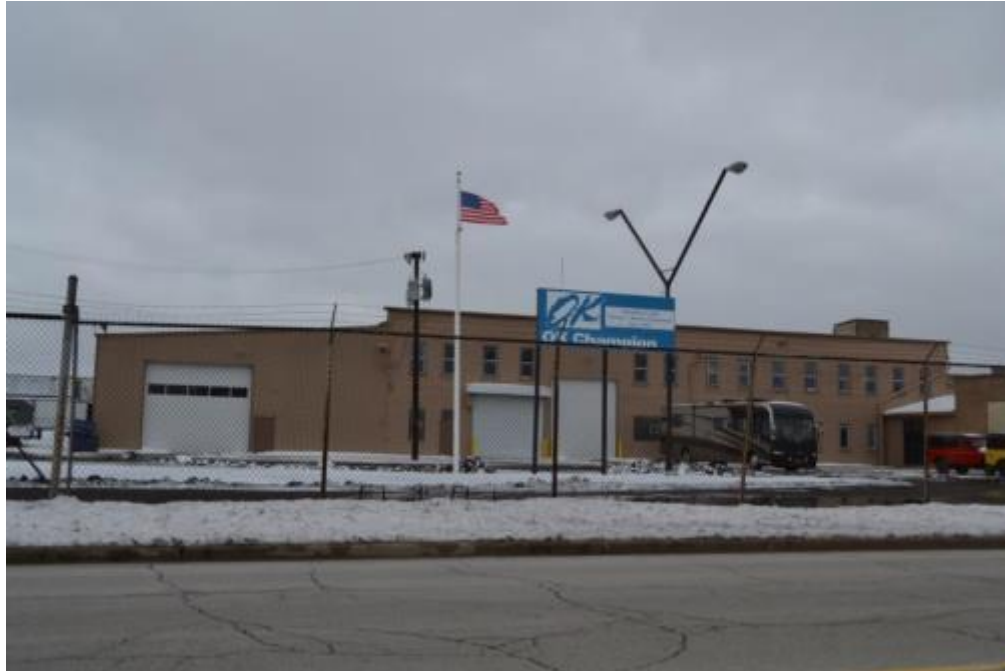
**Figure 5-54: Two-story Section of the O.K. Champion Building (view southeast)**

A two-story section of the building was constructed in 1908 and is connected to the south side of the three-story section by a steel- or wood-framed lean-to structure that was used as coal storage and a boiler room (Howat 1915; **Figure 5-54**). The first floor of the two-story section also is constructed of steel and concrete and housed another office and storage and factory spaces. Interiors are lit by numerous wire glass skylights. The east wall of the two-story section that faces Sheffield Avenue has metal-framed 1/1 double-hung windows with concrete sills and a window opening infilled with a small, fixed aluminum-framed window and glass blocks. Two large vehicle roll-up doors are not original to the building. A prefabricated steel lean-to addition with roll-up vehicle doors has been constructed on the south side of the two-story section of the building.

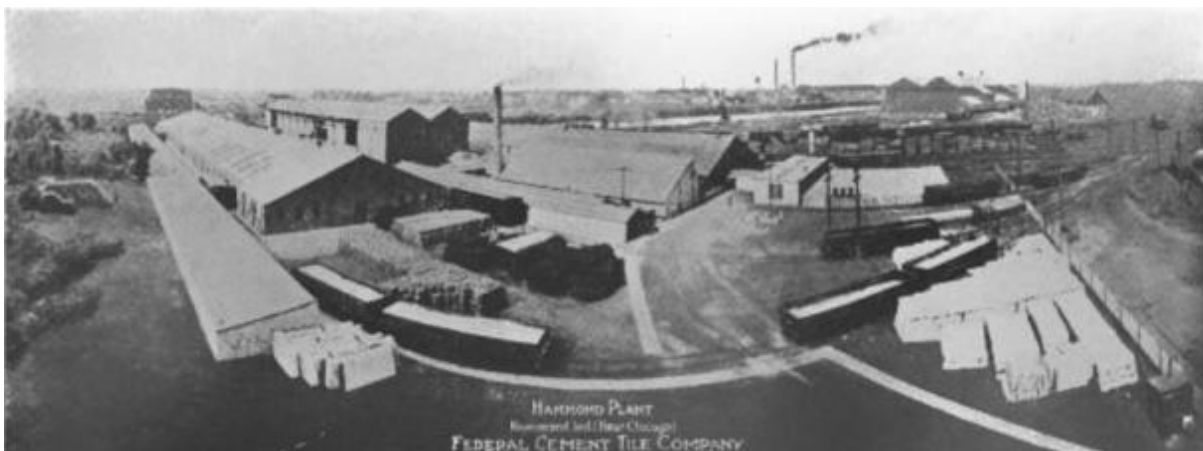
**Figure 5-55: Federal Cement Tile Company**  
(Published in the October 1919 Issue of *Concrete Magazine*)

At least four of the buildings remaining extant on the parcel appear to have been part of the original 1909 plant construction (**Figures 5-55 through 5-57**). Sanborn Fire Insurance maps indicate that an office and two additions to the factory buildings were constructed between 1916 and 1930. Historic aerial photographs and county assessor records indicate that an office addition was constructed in 1964, and a large addition to one of the factory buildings was constructed between 1964 and 1967. The factory buildings were constructed in an industrial vernacular style and the 1960s additions exhibit characteristics of Modern styles.
