# **Appendix B. Section 106 Consultation**

# Historic Property Report

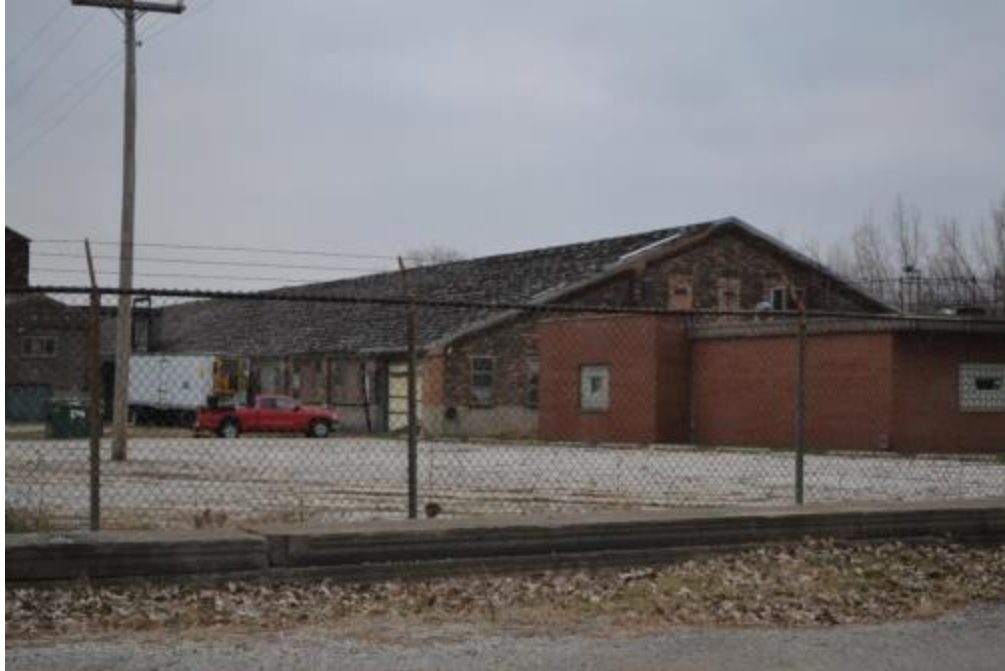
**Figure 5-58: Federal Cement Tile Company Shop No. 1 and Office Addition (view southwest)**

Three large, rectangular factory buildings and another small factory building probably were part of the original 1909 construction. These buildings are depicted on the 1916 Sanborn Fire Insurance maps. The three large, rectangular buildings are oriented with their short sides facing north and south. The building on the west was referred to on Sanborn maps as “Shop No. 1” (**Figure 5-58**). This building is one story and has a front gable roof. Additions were constructed on the back (south side) of the building between 1916 and 1930. Windows visible from the public ROW appear to have been infilled with brick and glass blocks. The central building, which was used for sand storage, is a two-story building with a double front gable roof. The original windows visible from the public ROW have been boarded over (**Figure 5-59**). The east building, which was labeled on Sanborn maps as “Shop No. 2,” is a one-story building with a front gable roof. The small factory building is located north of the central building and has a cross gable roof (see **Figure 5-56**). The 1916 Sanborn map identifies this building as the “coal room.” An adjacent brick chimney or smoke stack appears to have been shortened. Two original factory buildings that the Sanborn maps depicted to the north of the “coal room” are no longer extant.

Sanborn maps indicate an office was constructed north of the west factory building between 1916 and 1930 (see **Figure 5-58**). An addition was constructed to the office building in 1964 and the exterior of the original office was remodeled to match the addition. The office addition is an L-shaped one-story brick building with a flat roof and an interior brick chimney. The front public entrance has an aluminum-framed storefront door with a one-light window wall on the west side and a two-light window wall on the east. Metal-framed, vertical ribbon windows are

located on the front (north) wall on both sides the entrance block. Other window openings have small square or rectangular awning windows surrounded by fixed glass blocks. All windows appear to have concrete sills.

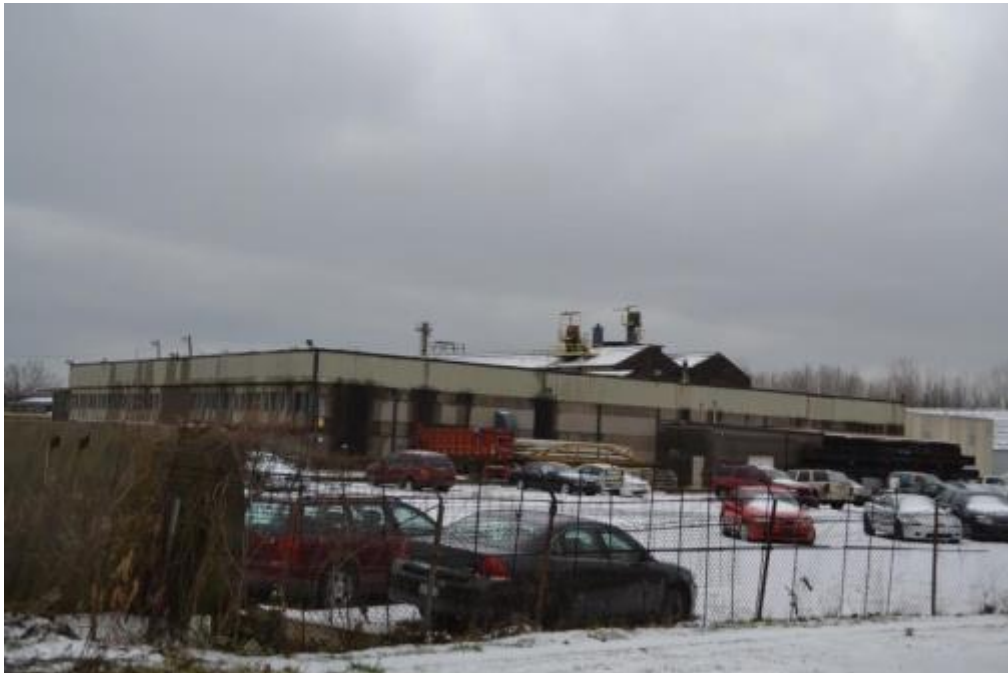
**Figure 5-60: Federal Cement Tile Company 1960s Addition (view southwest)**

Between 1965 and 1967, an addition was constructed on the front (north) of the east factory building (**Figure 5-60**). This addition is a one-story, steel and concrete structure with a flat roof with a corrugated metal parapet wall. The east side of the building has rows of vertical, aluminum-framed windows. The exterior walls are clad with alternating rows of concrete squares and rectangular slabs of lighter concrete or stone. A small, rectangular addition was constructed on the west side of the 1960s addition in the late 1990s or early 2000s. That addition also is constructed of steel and concrete and has a flat roof. The exterior walls feature pop-out concrete columns.

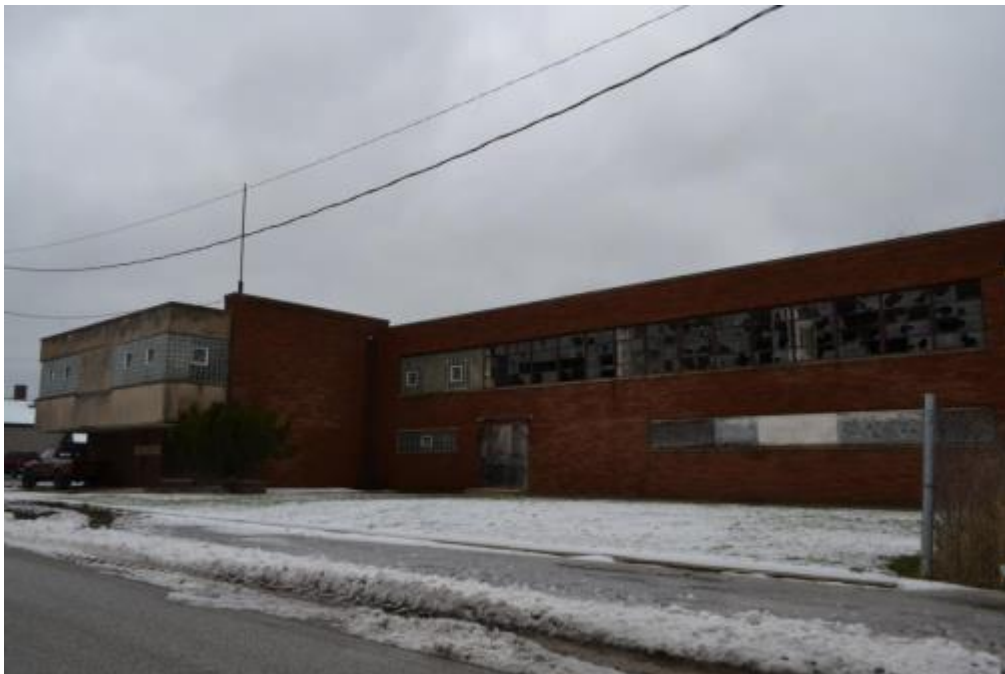
**Figure 5-61: 215 Marble Street (view northeast)**

The building at 215 Marble Street is a two-story commercial/industrial property that likely served as an office and warehouse space for the Junior Toy Company (**Figure 5-61**). It was constructed in the International style in 1952, just after AMF purchased the company. The L-shaped building has a low, horizontal orientation and faces south with the shorter base of the “L” perpendicular to Marble Street and trending north-south and the longer leg of the “L” parallel to Marble Street and trending east-west. The building was designed to provide office spaces in the shorter base of the “L” and warehouse space in the longer portion.

The building is constructed of brick and has a flat roof with parapets. The office portion of the building has a cantilevered second floor that provides second story office spaces and shades the first floor entrance. The front entrance has a storefront entry, but all door and window openings have been boarded over. The exterior wall surface of the second story overhang has

The warehouse portion of the building includes a delivery door that has been boarded over and long, horizontal banks of windows. Windows are either glass block with inset hopper/awning windows, or combination fixed and awning, or hopper windows with steel frames. Some of the window openings have been infilled with concrete block and some of the window panes are broken or completely missing.

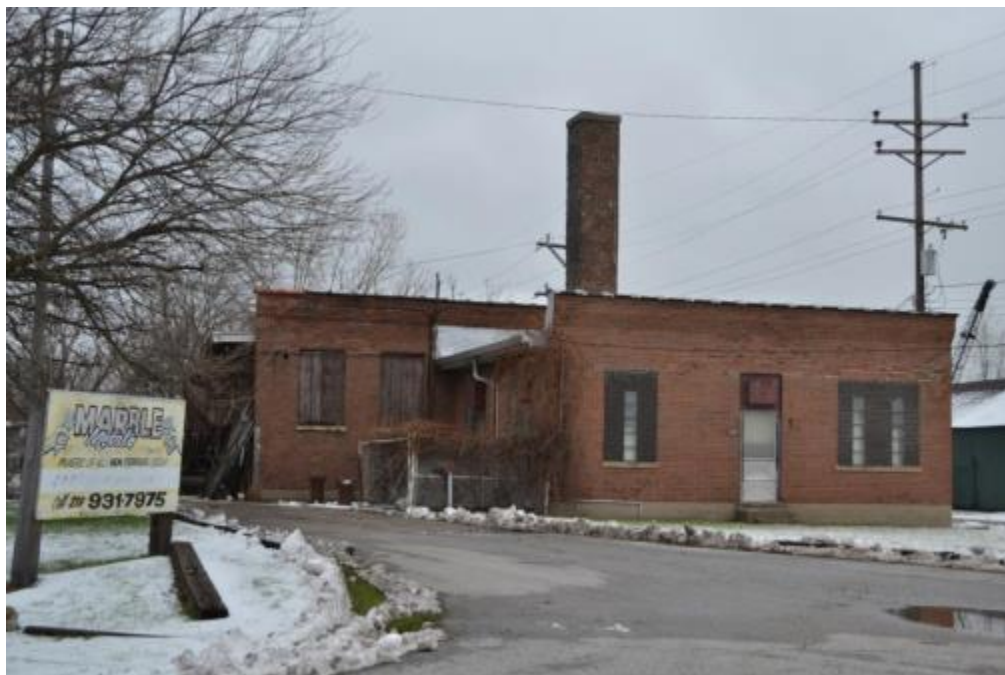
**Figure 5-62: One-story Building at Standard Indiana Bulk Oil Yard (view northeast)**

One of the buildings faces south, with its east elevation parallel to Wabash Avenue (**Figure 5-62**). The one-story building includes office spaces on the south end of the building and warehouse spaces in the north end. Sanborn maps indicate that the building has a basement and historically housed an office, locker room, and two garage spaces. Most windows in the buildings are utilitarian, steel-framed windows with a combination of fixed lights and awning or hopper windows with concrete sills. The office spaces have more decorative windows, which consist of five vertically stacked glass block windows with a three-sided grey brick surround and concrete sills. Basement windows are similar in style, except that there are only four glass blocks stacked in a 2/2 pattern. The utilitarian steel-framed windows on the east side of the building have been boarded over. This building also has a decorative brick cornice.

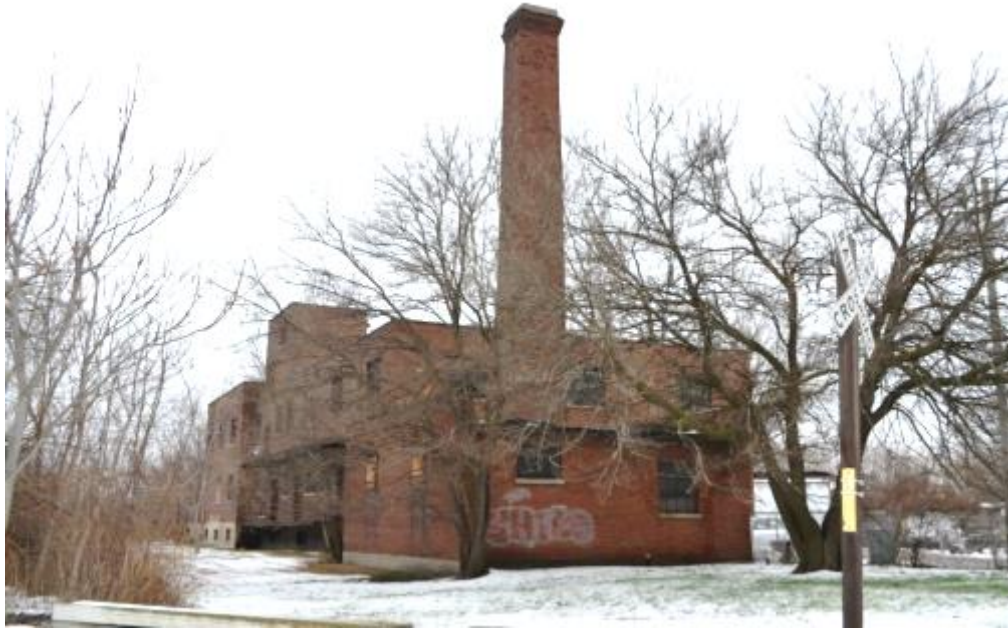
**Figure 5-63: Two-story Building at Standard Indiana Bulk Oil Yard (view northwest)**

The two-story building is west of the one-story building and faces southwest (**Figure 5-63**). Sanborn maps indicate that this building has a basement, steel columns, concrete floors, and 18 inch roof parapets. Most of the building was historically used as an oil warehouse with two oil tanks and a barrel filling area. A one-story heating plant was attached to the southeast side of the building where the chimney is located, and a one-story barrel storage room with a basement

was attached to the northwest side of the building. Windows in this building all appear to be steel-framed windows with a combination of fixed lights and awning or hopper windows with concrete sills.

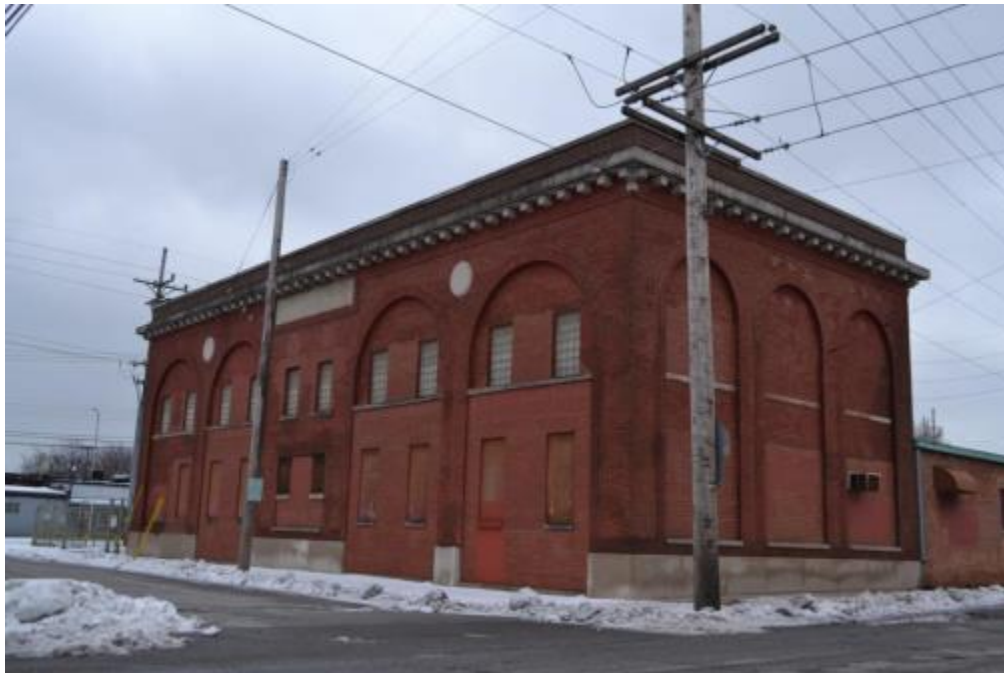
**Figure 5-64: NIPSCO Substation (view southeast)**

The Northern Indiana Public Service Company (NIPSCO) Substation building at 4533 Hanover Street is a two-story Neoclassical-style building constructed in 1918 (**Figure 5-64**). NIPSCO is the largest gas utility and second largest electrical utility in Indiana that provides services to the industrial region in the northern part of the state. The influx of industry and the construction of several railroad lines in the Calumet area in the late 19th and early 20th centuries led to the consolidation of several existing utility companies. NIPSCO was first established in 1912 under the name Calumet Electric Company, which was eventually acquired by the Midland Utilities Company. In 1923, Midland Utilities Company acquired the Northern Indiana Gas and Electric Company and three years later the corporate name was changed to NIPSCO (International Directory of Company Histories 1992).

The NIPSCO Substation is a brick building that faces north. It has a flat roof with parapets and an exterior chimney. The cornice features a dentil course and other stone detailing. The front wall features a blind arcade with window openings within the outline of the arches. Second story windows are fixed glass block windows with stone sills. First-story windows also have stone sills, but all openings have been infilled. The addition has large square infilled window openings and an infilled door with segmental arch surround on the west side. Most window openings within the building are infilled. Other doors are single and double entries. The electrical substation facility is adjacent to the building to the east.

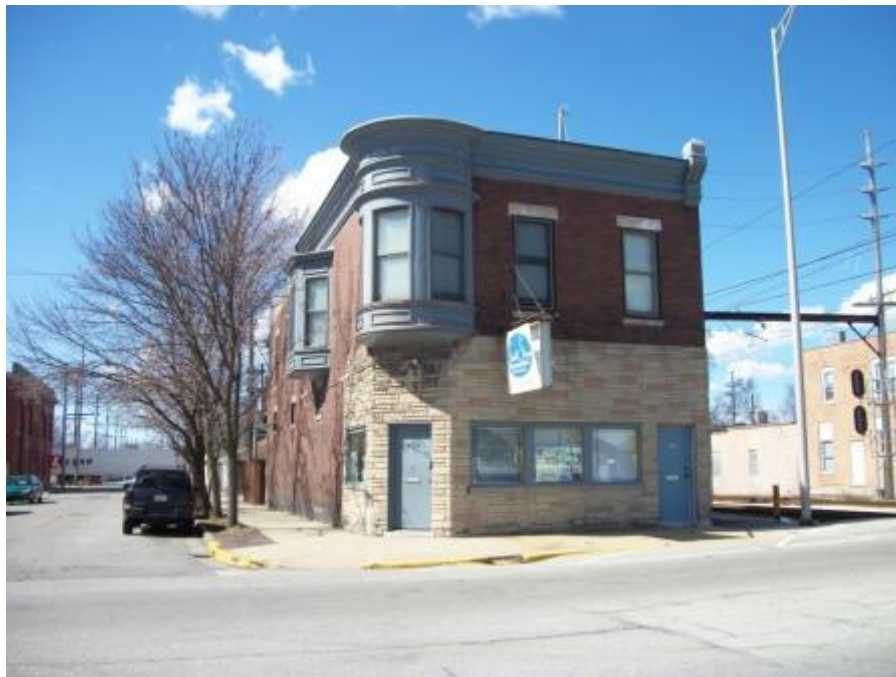
**Figure 5-65: 4534 Hohman Avenue (view northwest)**

The Nevills and Carr Saloon at 4534 Hohman Avenue is within a commercial area north of the Grand Calumet River in Hammond. This area, which is about 0.7 mile north of the downtown Hammond commercial area, was developed in the vicinity of the Baltimore & Ohio Railroad and the Chicago South Shore & South Bend Electric Railway in the late 19th and early 20th centuries. The brick commercial building at 4534 Hohman Avenue was designed in a commercial vernacular style with design elements of the Queen Anne style (**Figure 5-65**). Prior studies indicate the building was constructed circa 1925, but Lake County Assessor's records indicate the building was constructed in 1905. Hammond City Directory entries indicate that the building was occupied by the Nevills & Carr Saloon in the early 1910s. Max Lovinger took over the saloon circa 1916. In the 1920s, the building housed the Matteoni & Nottoli Confectioners. Mr. Matteoni continued to operate a confectioners business in the building into the 1930s.

The roof is flat with parapets and the cornice is decorated with inset wooden panels. The building features a corner entry that faces southeast. The first floor storefront, which includes the corner entry, the east façade, and a small portion of the south façade, is faced with ashlar stone and includes a single entry metal door in the southeast corner and another single entry metal door on the east side. Windows within the store front include fixed picture windows (one on the south side and a set of three ribbon windows on the east side). A round, cantilevered second-story turret with a flat roof projects over the first floor corner entry and a projecting bay window is located on the second floor on the south side of the building. Both the turret and the bay window have decorative elements consistent with the Queen Anne style, including inset wooden panels.

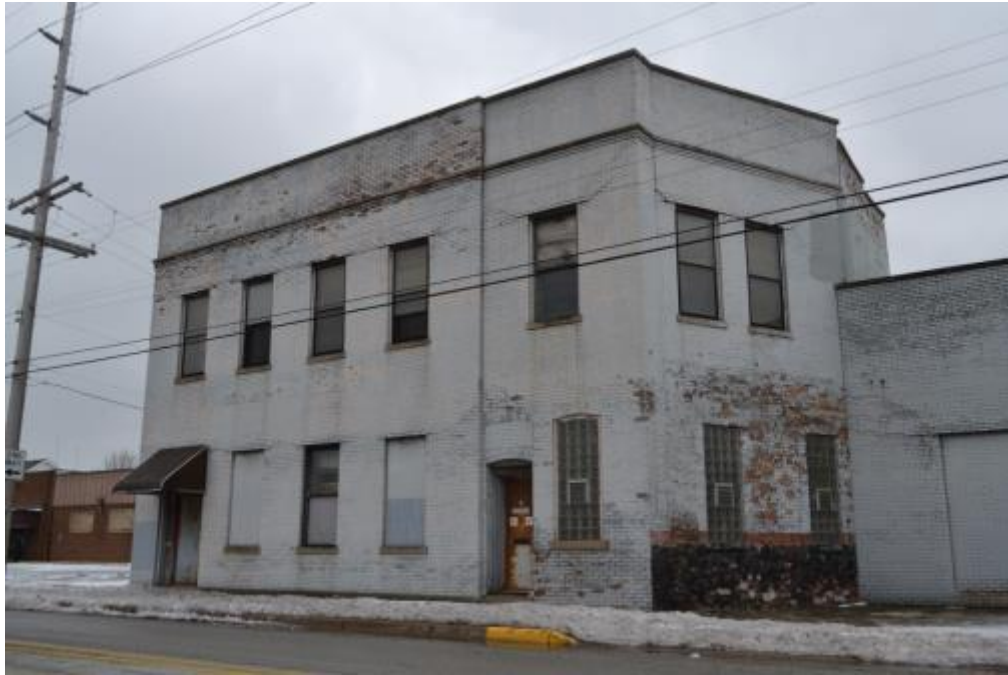
**Figure 5-66: 304 Gostlin Street (view southeast)**

The property consists of a two-story commercial building (**Figure 5-66**) and an attached one-story warehouse (**Figure 5-67**). The buildings are both constructed of brick, have flat roofs with parapets, and face north. The northwest corner of the commercial building is angled. There is a cascading brick stringcourse between the roof parapet and the second story windows. Most windows in the commercial building are 1/1 double-hung window, but three windows on the first floor have been infilled with fixed glass block. One of those windows and the adjacent recessed single entry door are framed by brick segmental arches. Another single entry door on the front (north) of the building is a single entry metal door with an awning. The east side of the commercial building, which faces an alley, does not possess any ornamental architectural

details. Windows are 1/1 double-hung and multi-light steel frame windows. There also is a large double entry that has been boarded over.

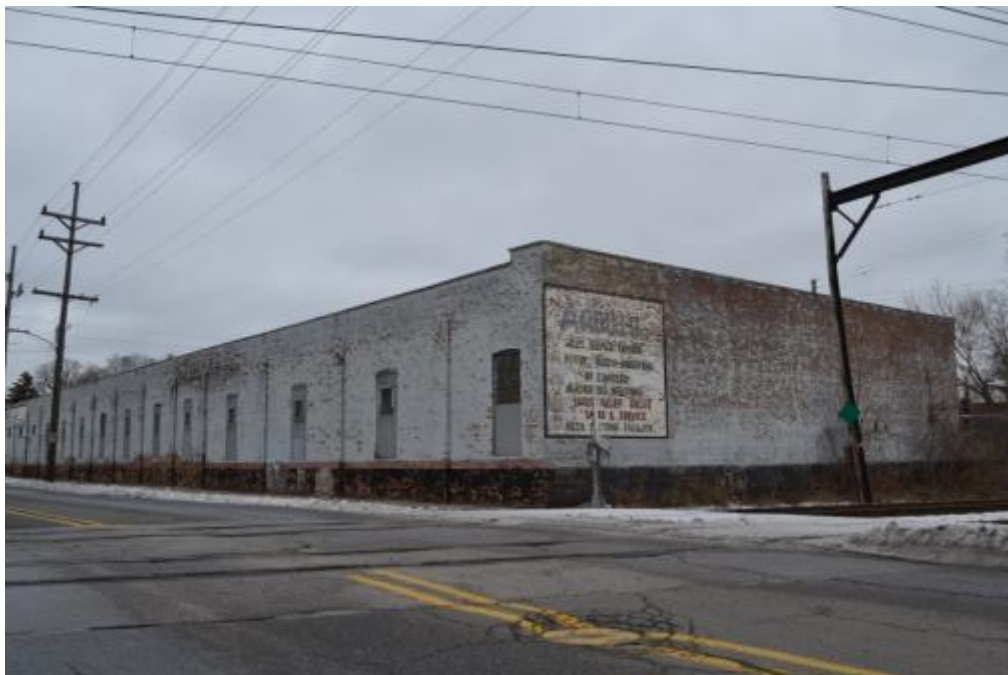
**Figure 5-67: 304 Gostlin Street (view northeast)**

The one-story warehouse portion of the building has three large vehicle openings on the north side. One of those has been infilled with brick and the other two have roll-up doors. There also is a single entry door with a transom. The west side of the warehouse has 14 segmentally arched window openings. The windows are partially infilled with plywood and either multi-light steel framed windows or four-light steel windows.

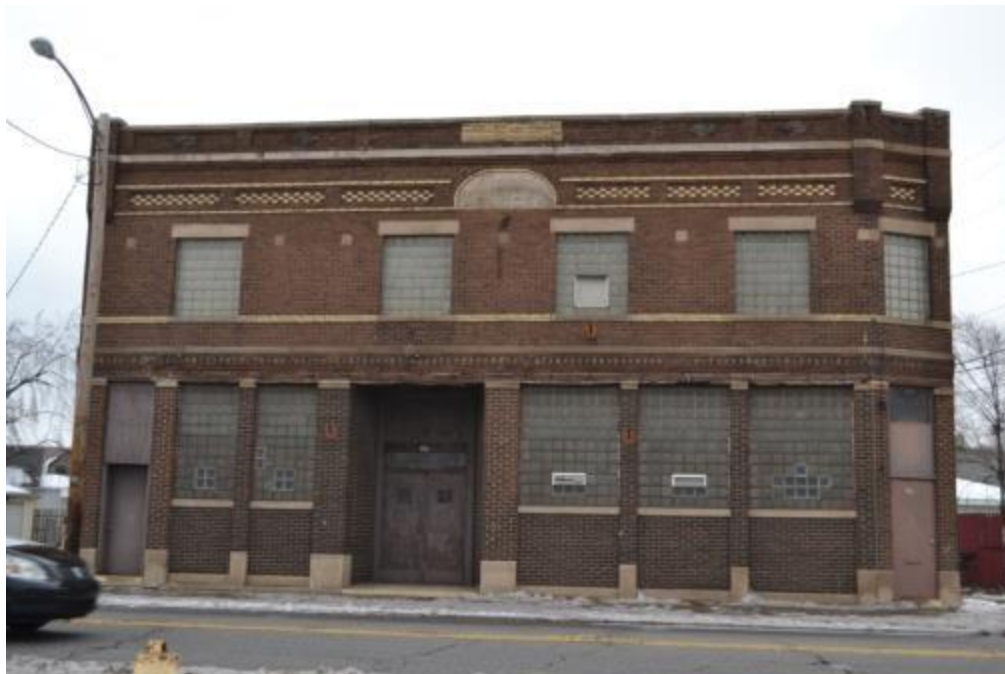
**Figure 5-68: Polish Army Veterans' Post (view north)**

The Polish Army Veteran's Post No. 40 building is a Neoclassical style building constructed in 1914 (**Figure 5-68**). The two-story brick building has a corner entry and diagonal front façade to follow the diagonal line of Gostlin Street to the south. The first story has two single entry doors with transoms (one infilled and the other partially infilled) and a recessed double entry with a transom. Windows are fixed glass block windows. The doors and windows are separated by brick piers with concrete bases. The first and second stories are visually separated by a concrete band course. Upper story windows are fixed glass block windows with concrete sills. A semi-circular concrete nameplate identifying the building as the "1914" block is edged with light colored brick and bordered by another line of light colored brick and recessed panels with a brick checkerboard pattern. The building has decorative brickwork at the cornice at the building corners. Additions have been constructed to the rear of the building. The building also has an interior chimney. Other windows on the side elevations include 1/1 double-hung windows with stone sills.

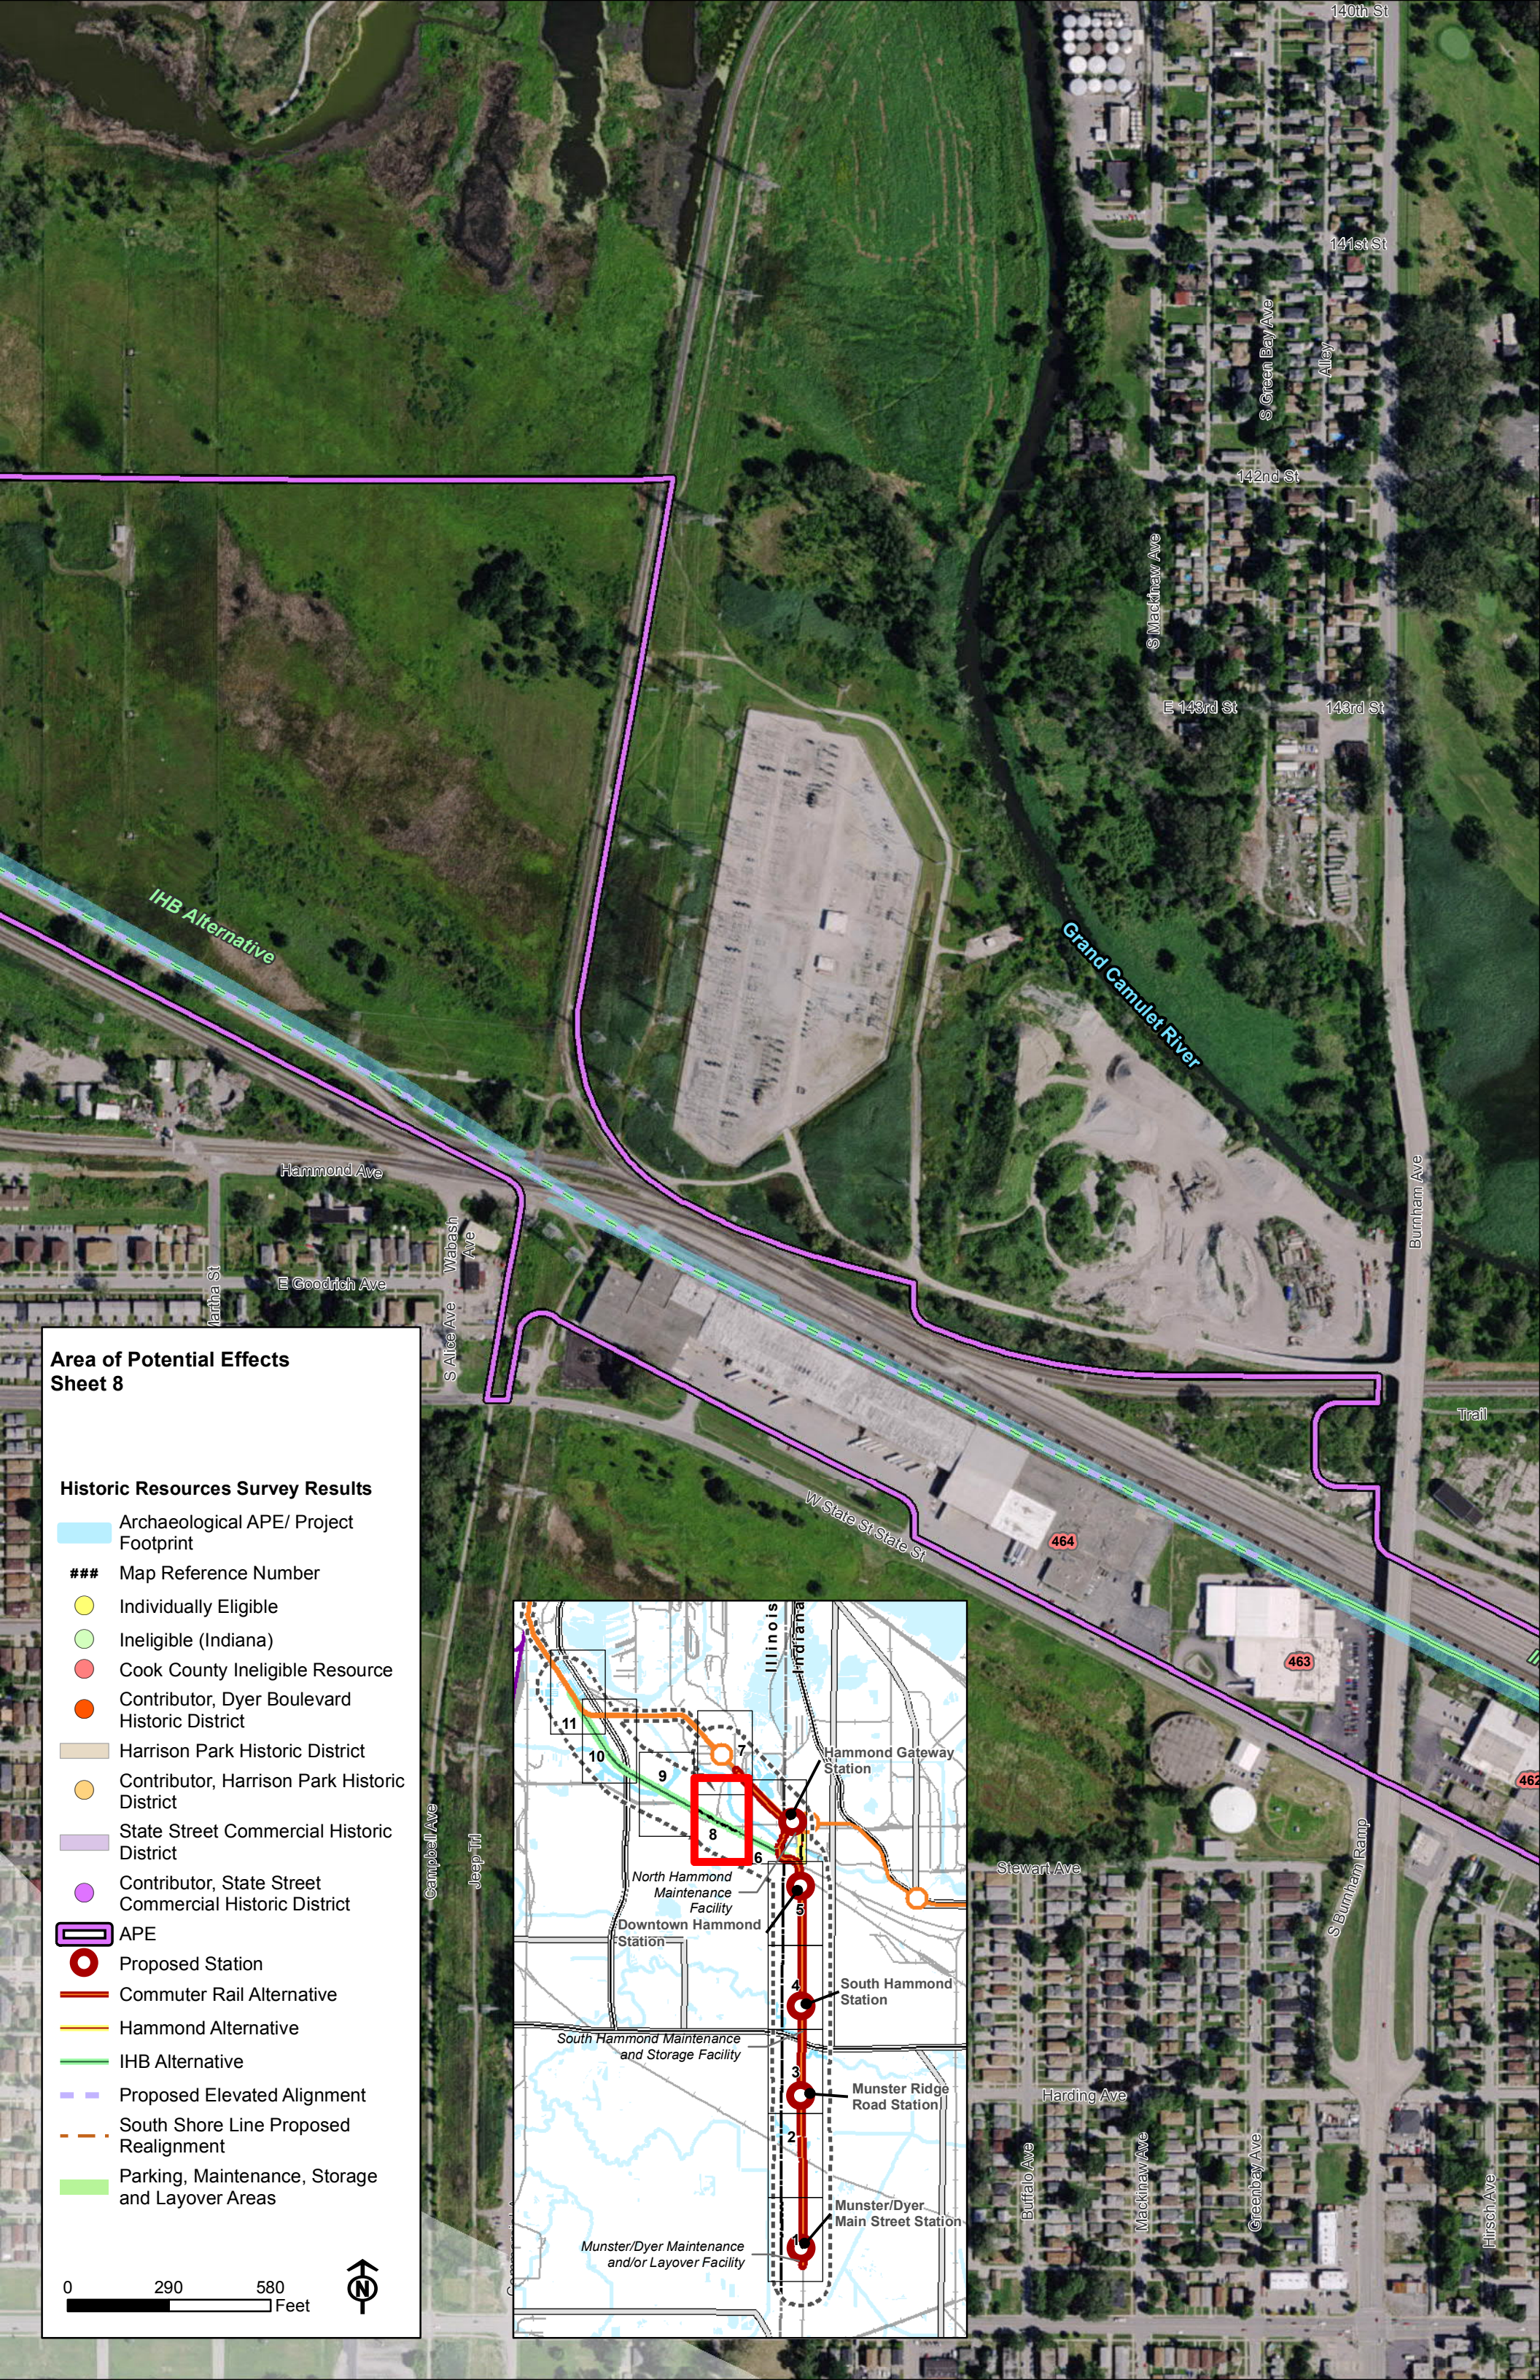
**Area of Potential Effects  
Sheet 7**

**Historic Resources Survey Results**

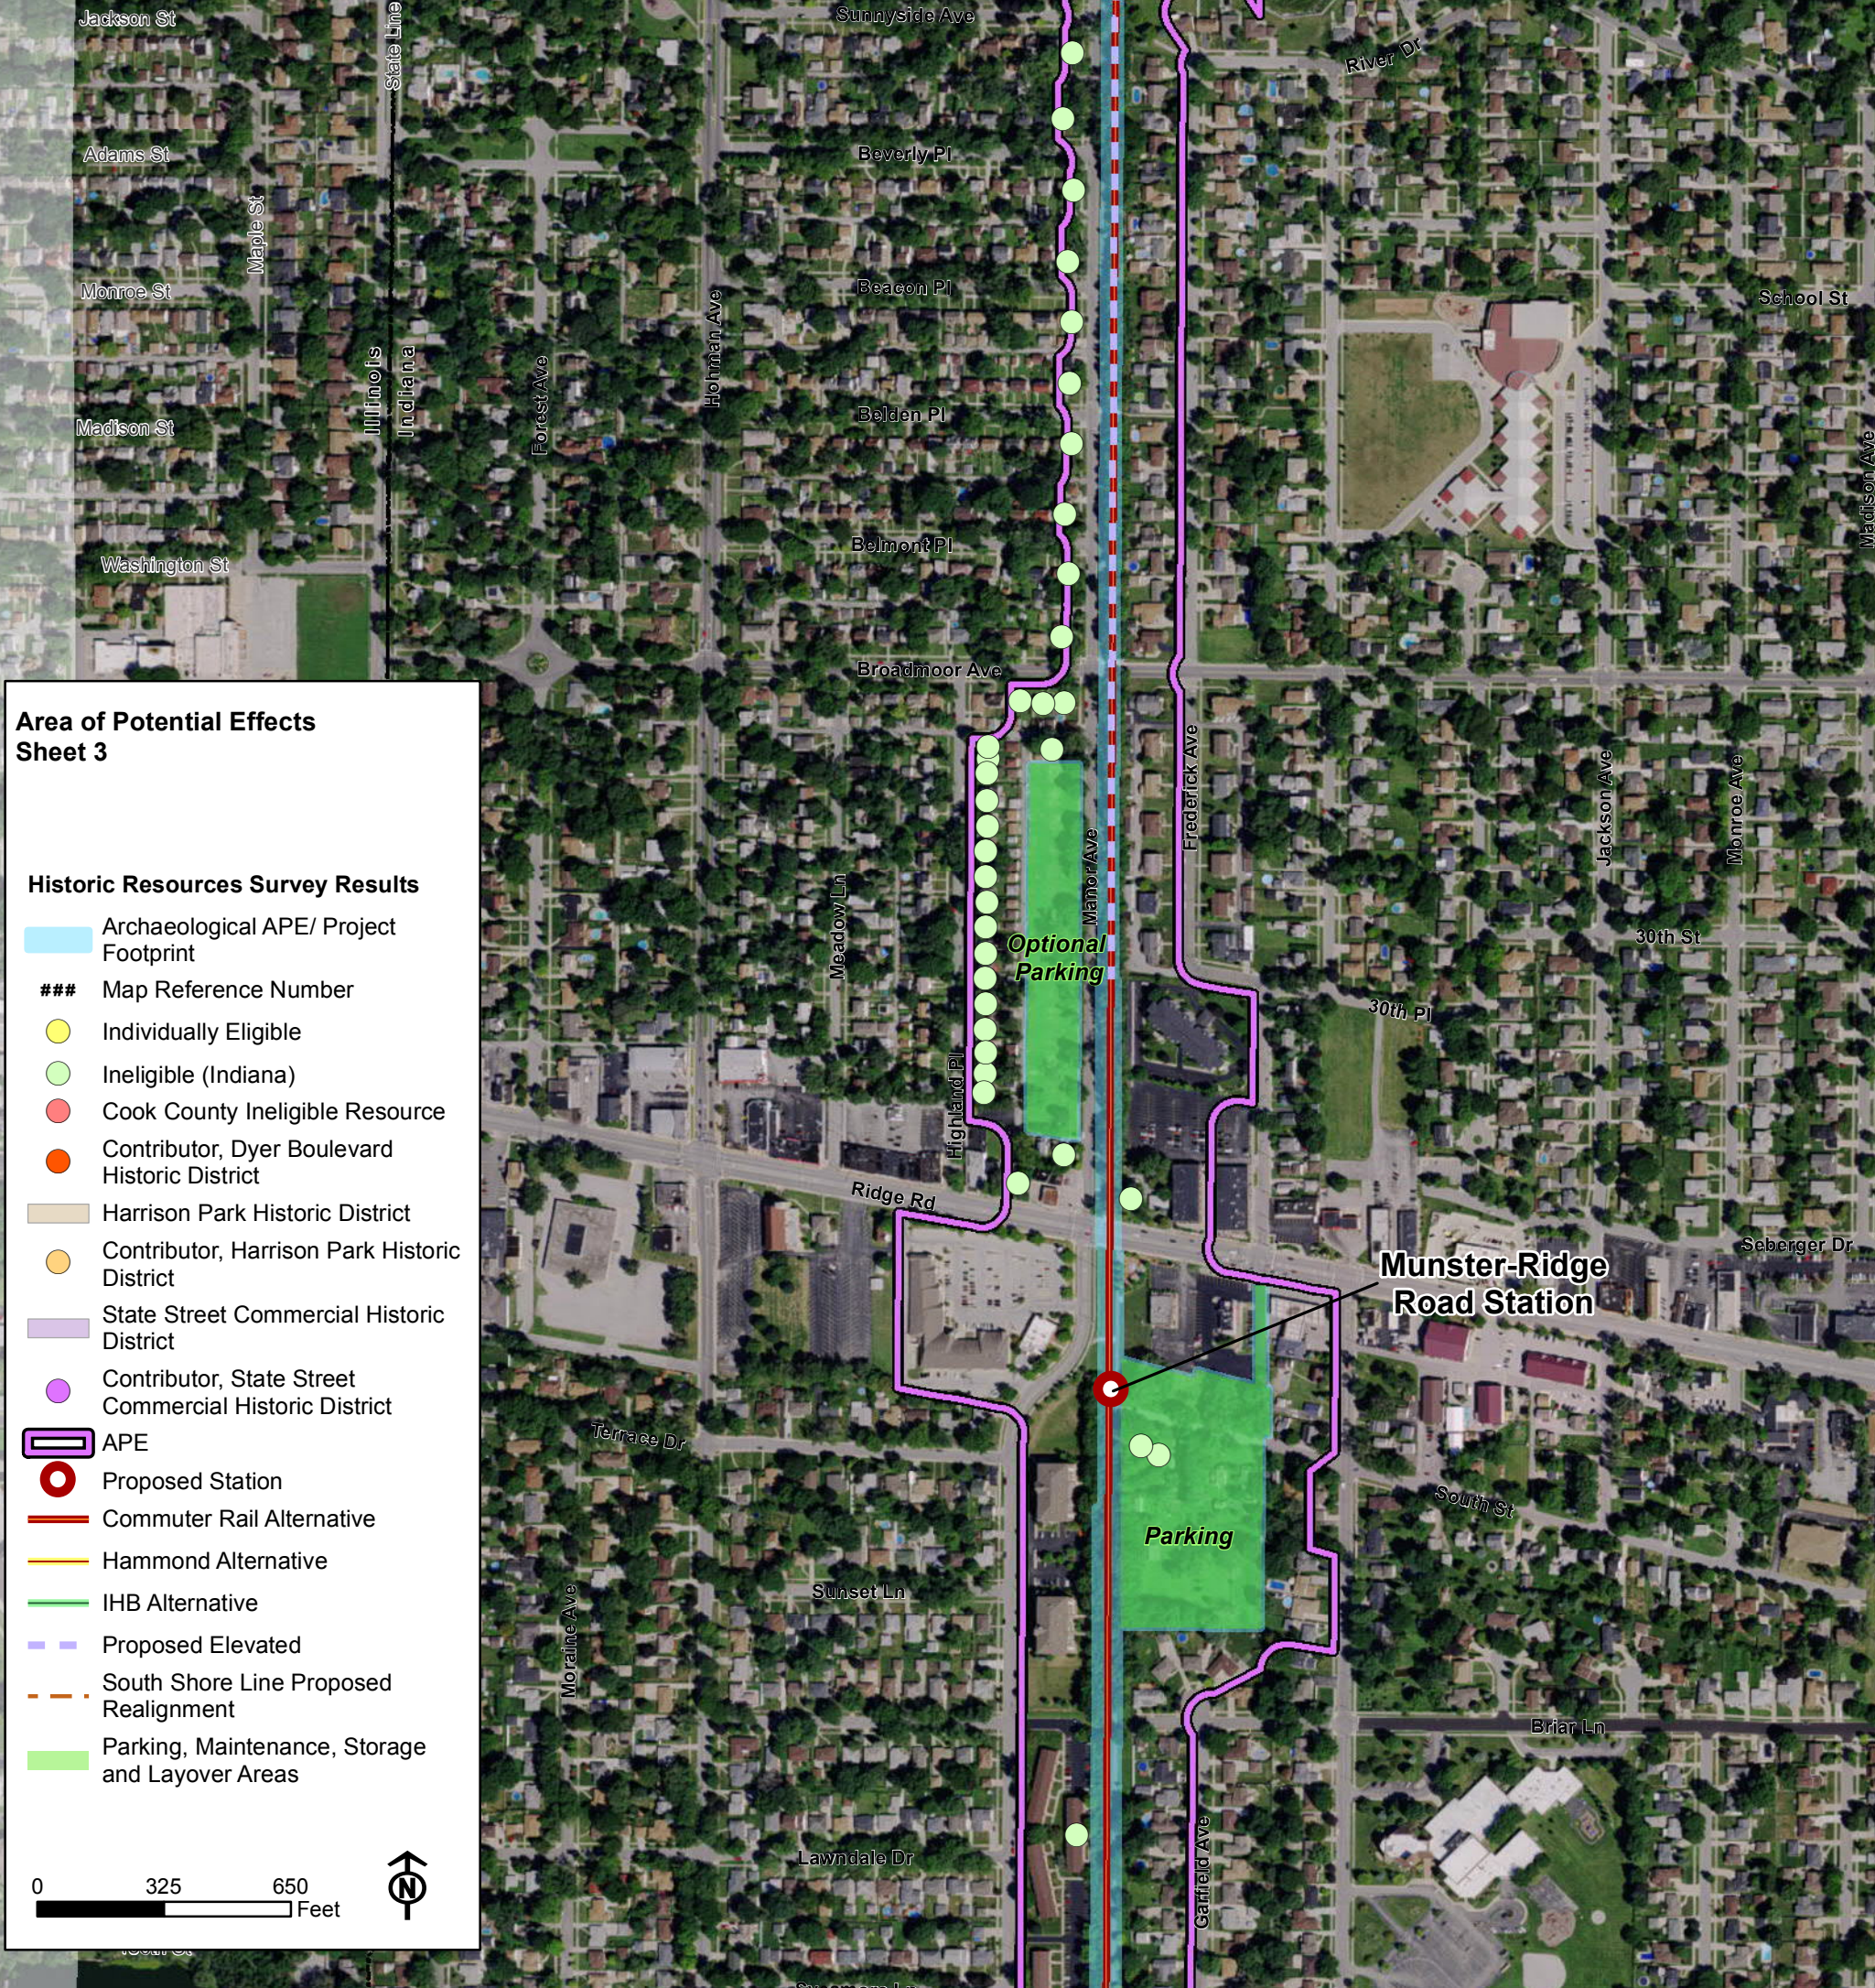
**Area of Potential Effects  
Sheet 3**

**Historic Resources Survey Results**

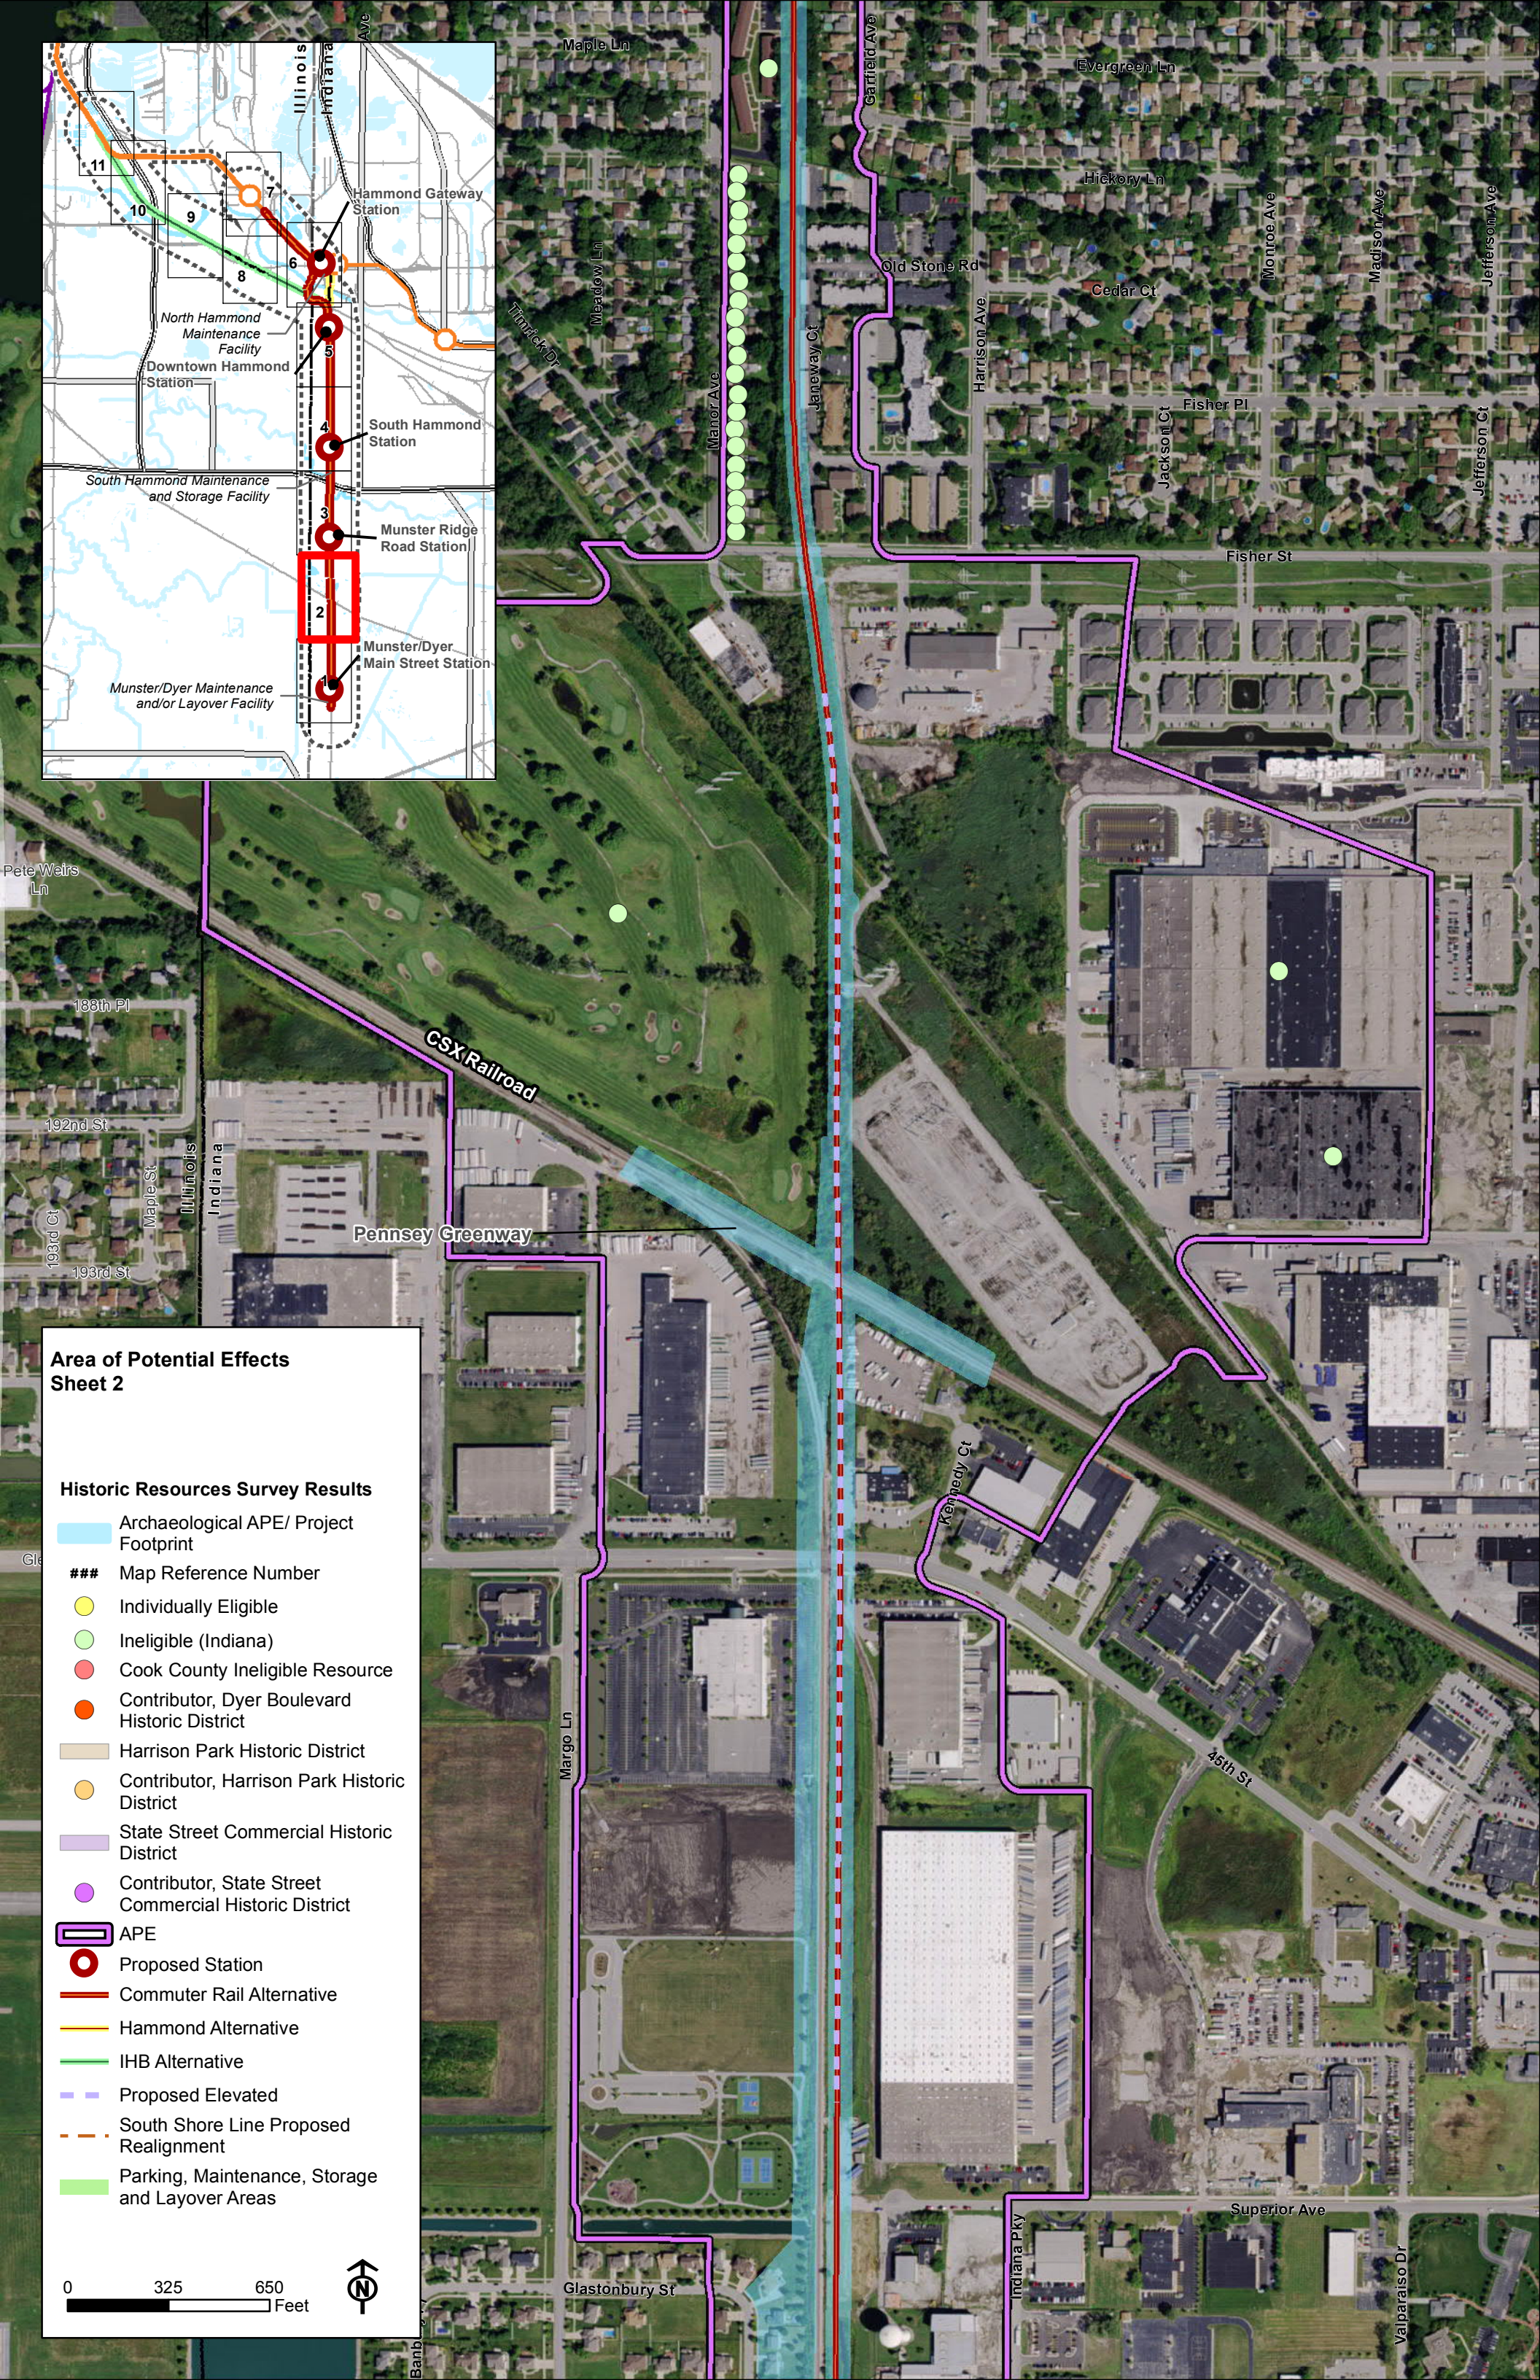
**Area of Potential Effects  
Sheet 2**

**Historic Resources Survey Results**
