# **Appendix B. Section 106 Consultation**

# Historic Property Report

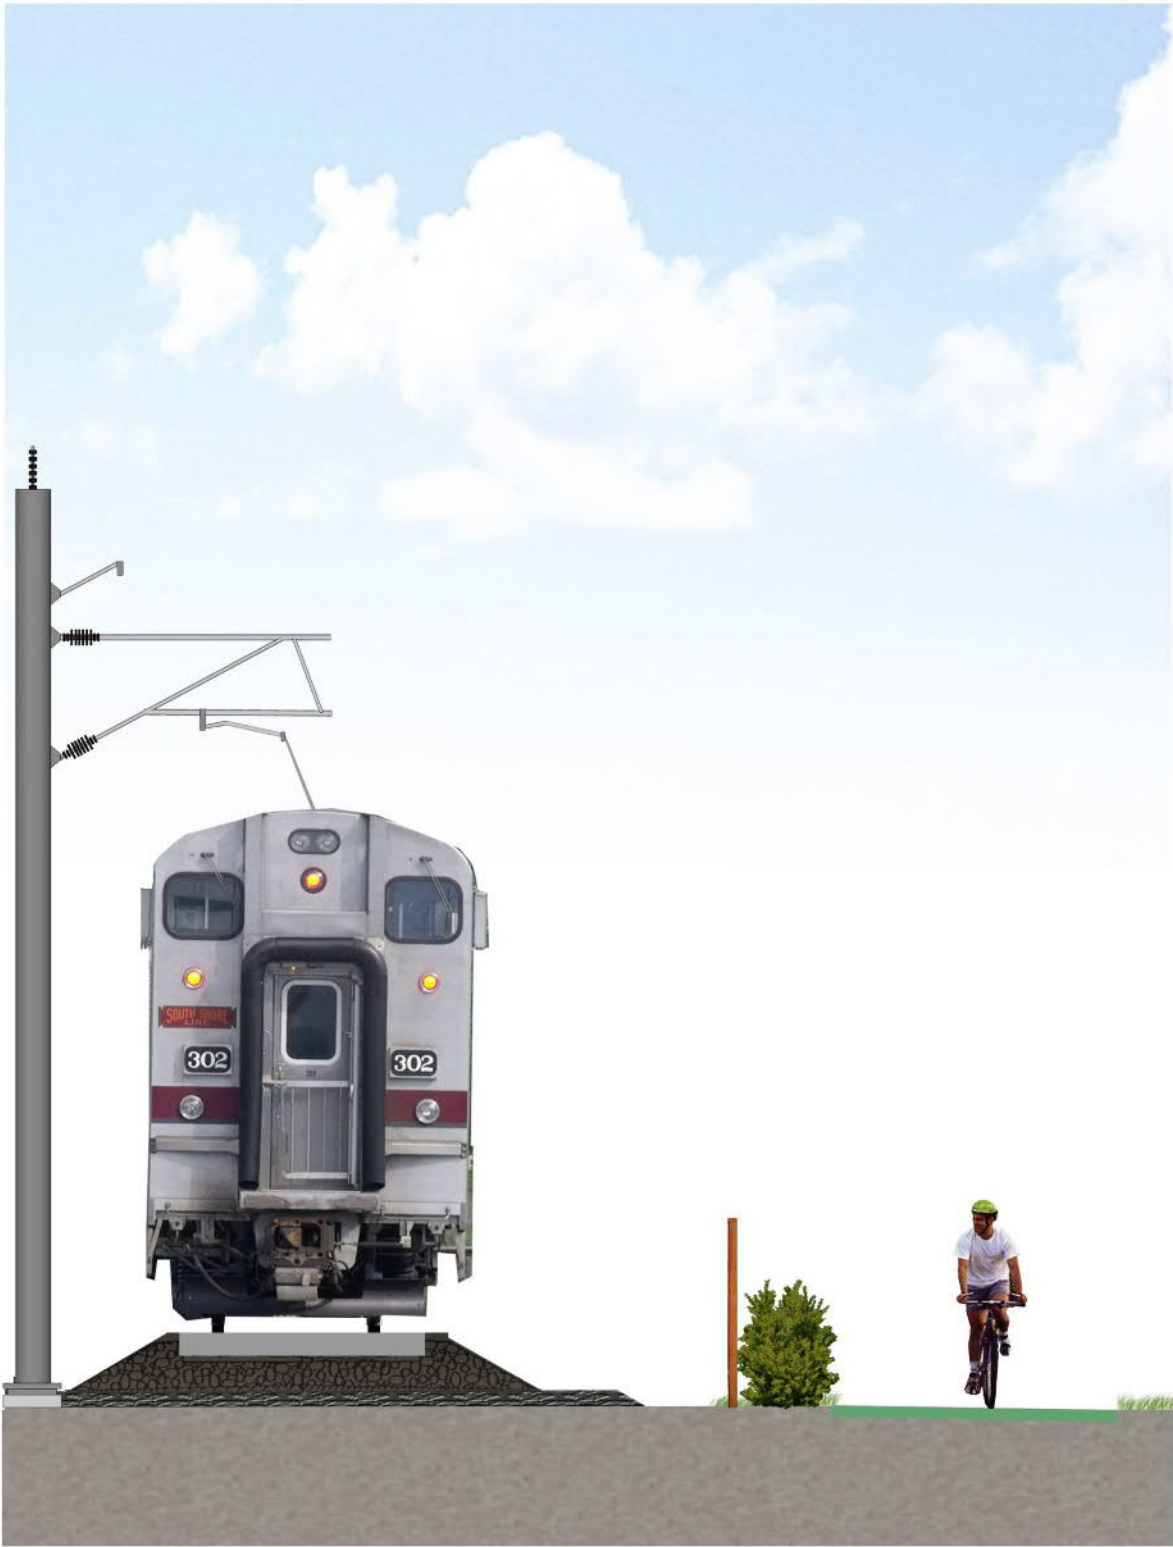
**Typical Section Exhibits**

Proposed Alignment adjacent to the Monon Trail, along the eastern boundaries of the Dyer Boulevard Historic District and the Harrison Park Historic District
